Canning Stock Route Audit Report

Prepared for Track Care WA
Author: Rod Durston
August 2022
Revised June 2023

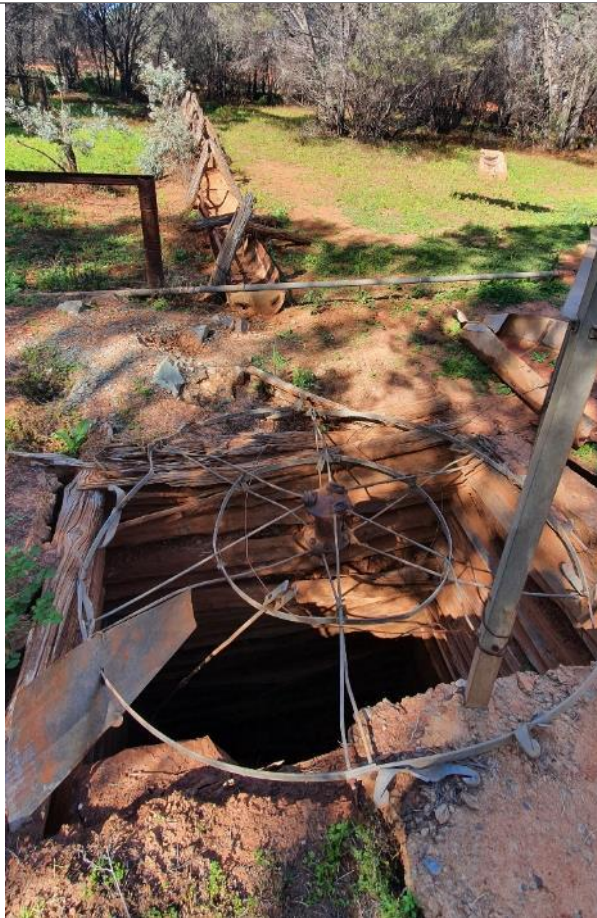
Well 1	Lat. -26.558031	Long. 120.181659
Description		
Still contains some water but unmaintained. Water tanks, dense woodland around well area, gravel/mud base, boggy when wet.		
Drinking Water <input type="checkbox"/>	Toilet <input type="checkbox"/>	Campsite <input type="checkbox"/>
River/Creek <input type="checkbox"/>	Grass <input type="checkbox"/>	Donation Box <input type="checkbox"/>
Vegetation	Low <input type="checkbox"/>	Med <input checked="" type="checkbox"/>
		High <input checked="" type="checkbox"/>
		Shade <input checked="" type="checkbox"/>
		BBQ <input type="checkbox"/>
		Animal Use <input type="checkbox"/>
		Signage <input checked="" type="checkbox"/>

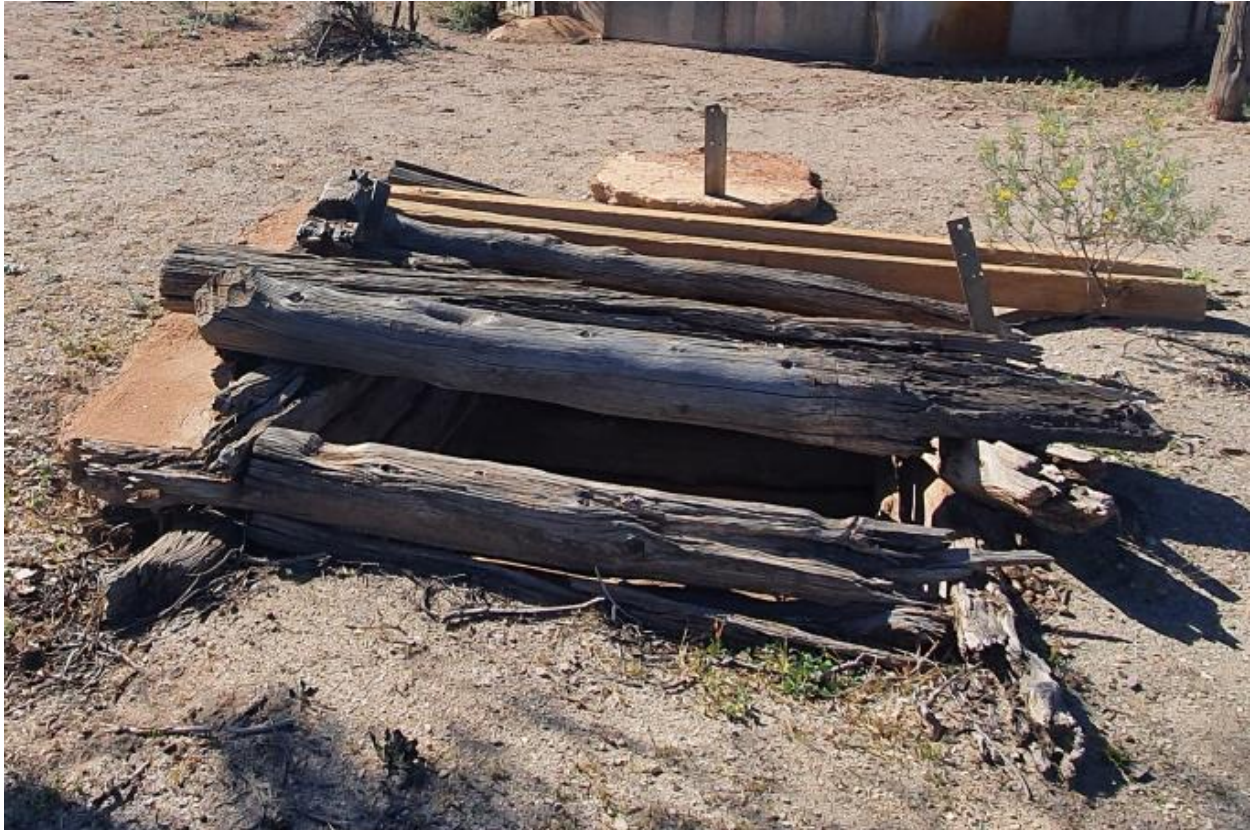
Well 2 Kalkalong

Not maintained, gravel surface & low scrub.

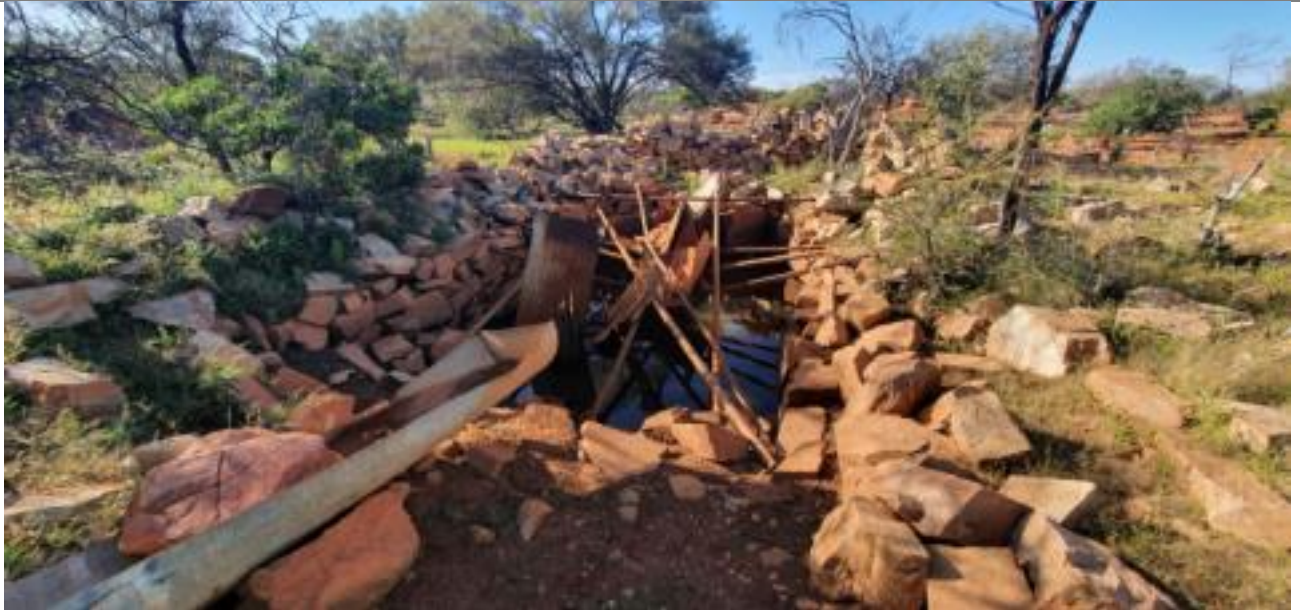
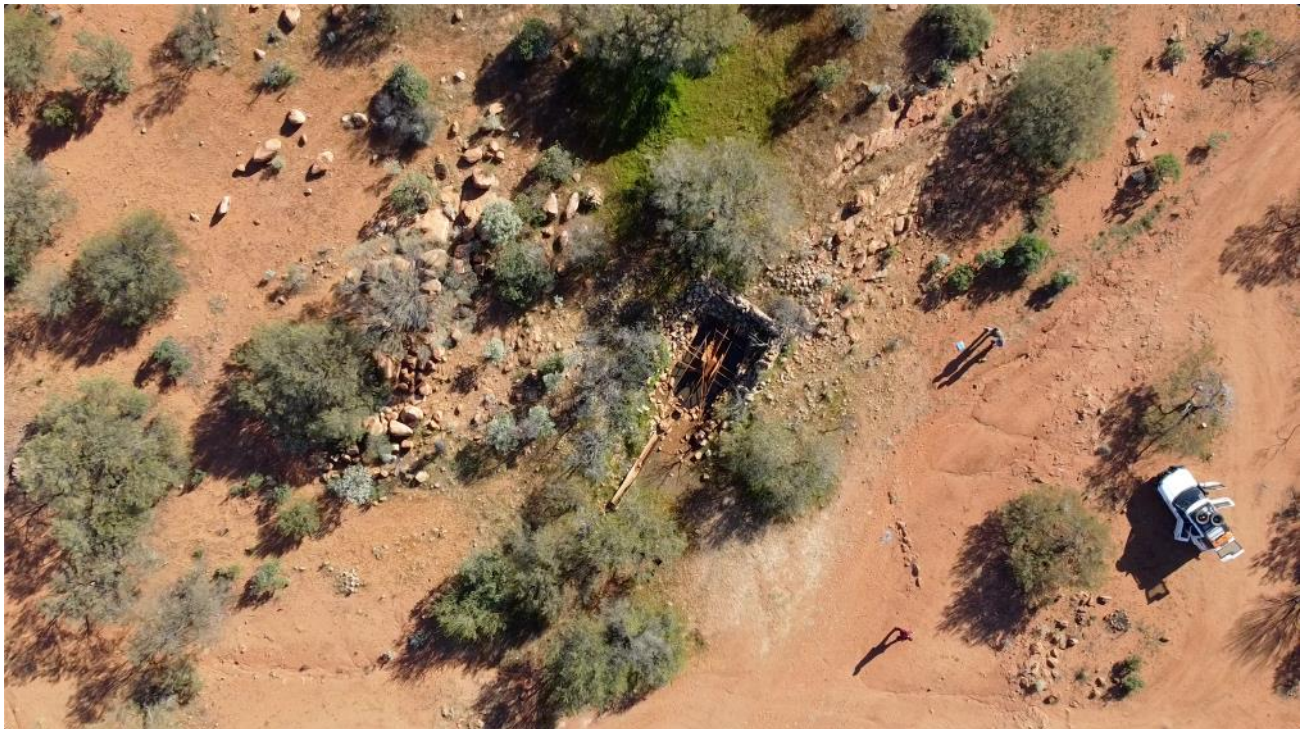
Well 2A The Granites

Some water but mostly destroyed. Low scrub

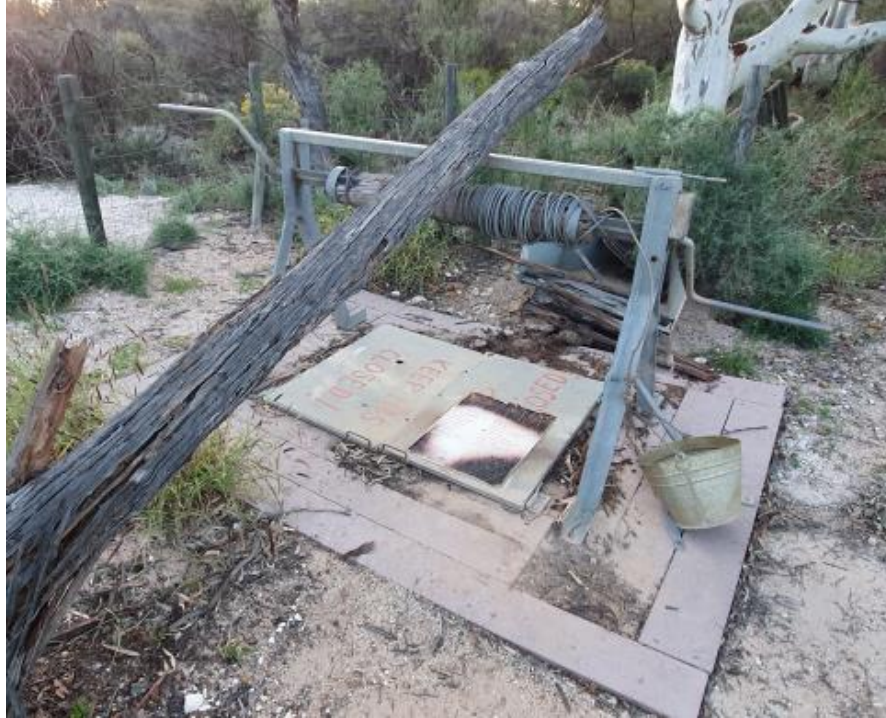
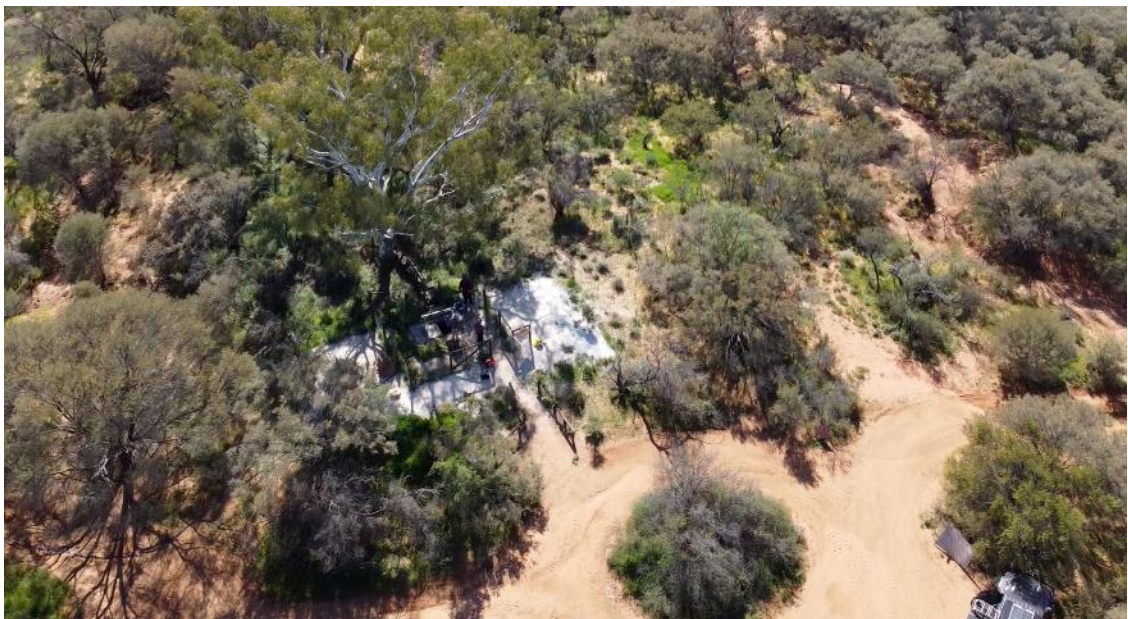
Well 3 Wakunpu

Restored Well. Dense woodland around camp area, no shade, sand base. Water is very smelly.

Top of Water 2m**Depth 5.3m**

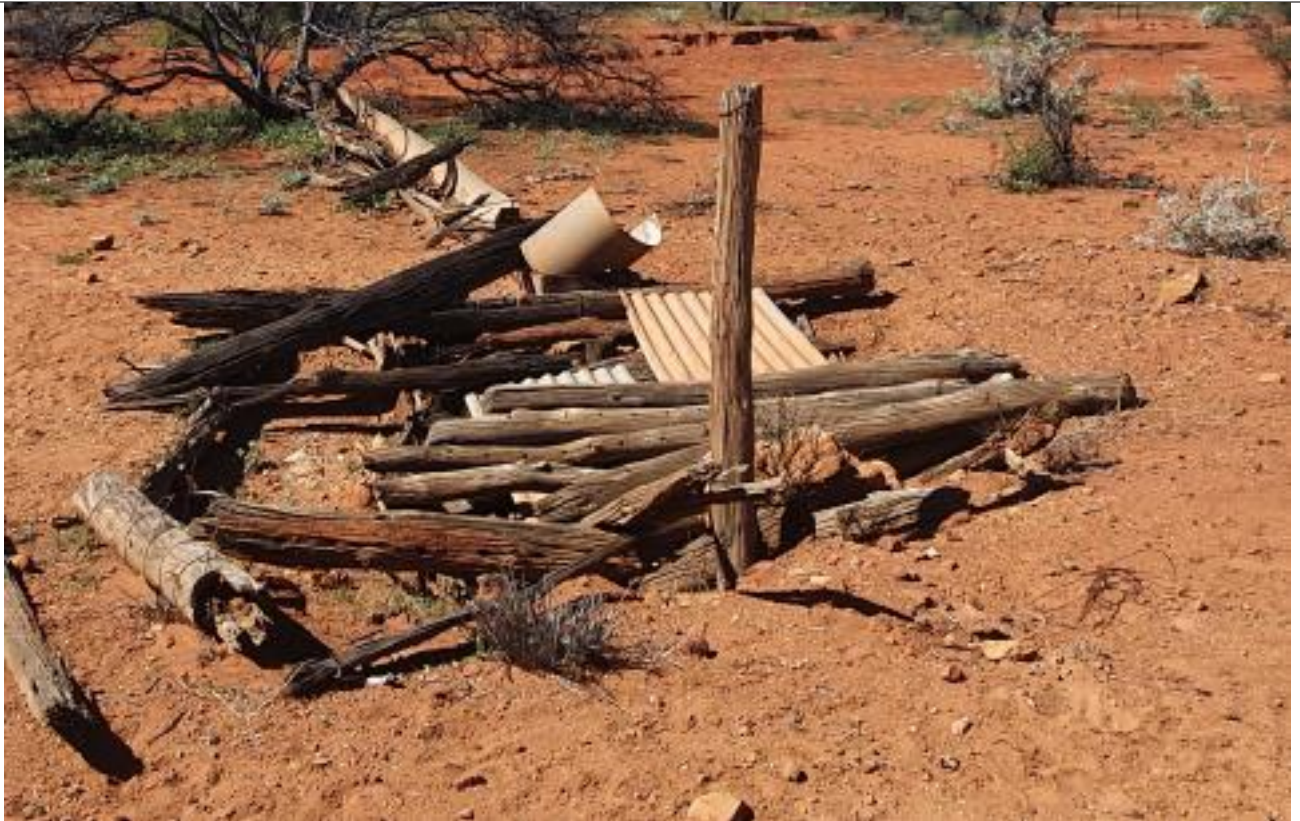
Well 3A

Scattered timbers and iron covering well but largely destroyed. Degraded woodland surrounds, sand base.

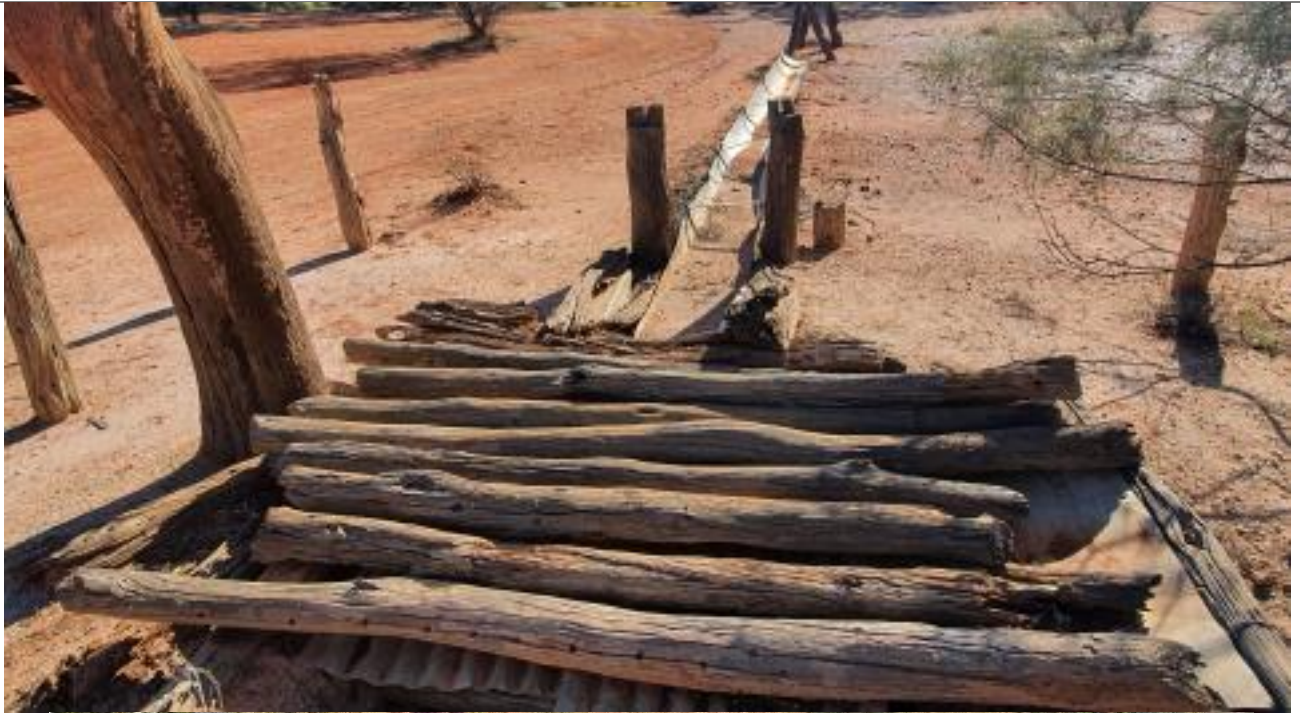
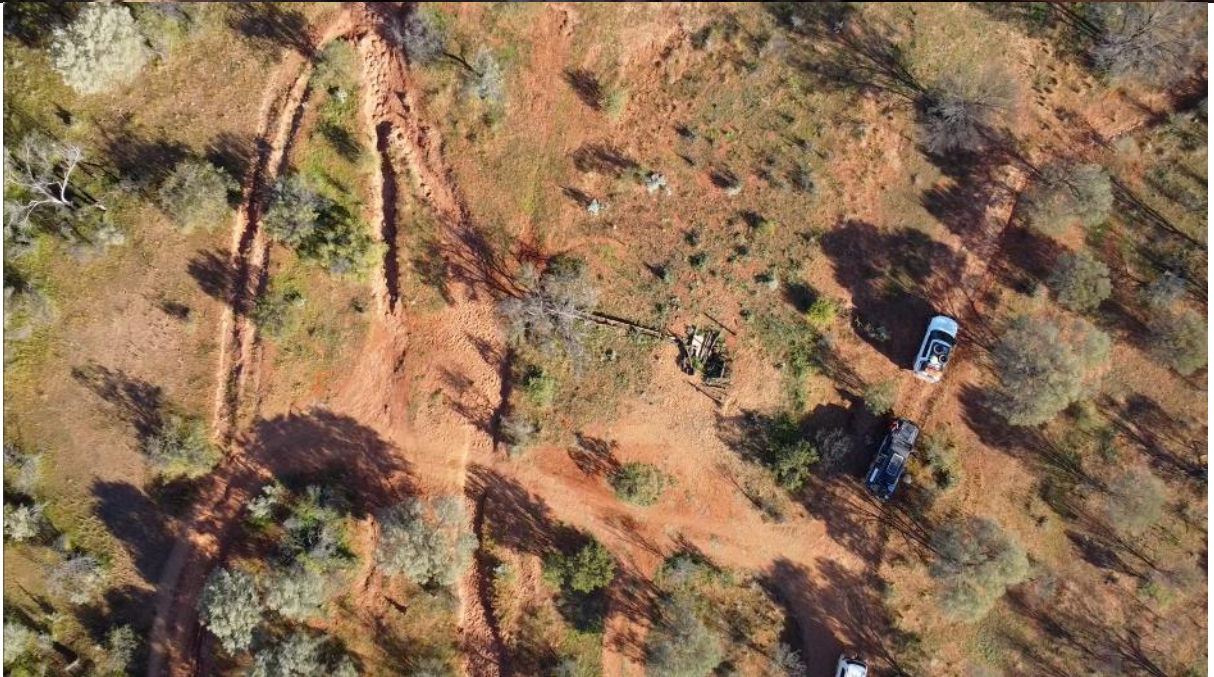
Well 4A

Unmaintained covered with iron and timbers, gravel base, White Gums along creek, Caltrop weed present, Survey marker nearby

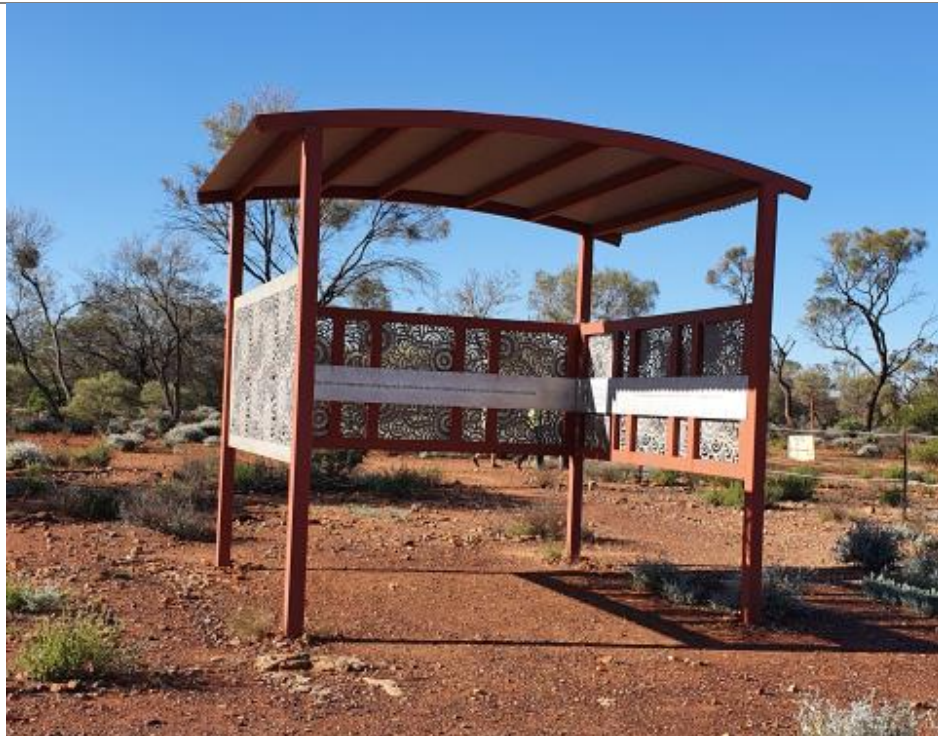
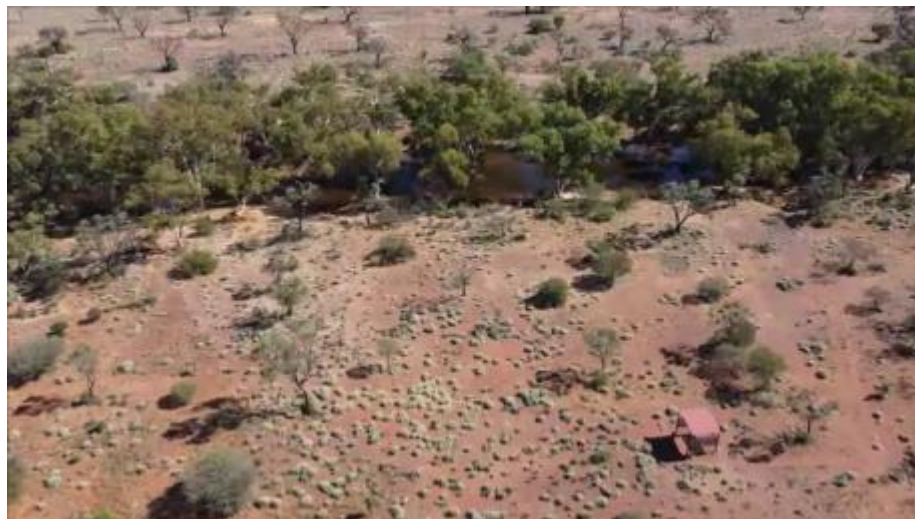
Windich Springs

Popular camping spot with abundant birdlife and permanent water supply. Shaded Information display, toilet in good repair, Solar light needs replacing, picnic tables x2, gravel/stone base, dense woodland along creek.

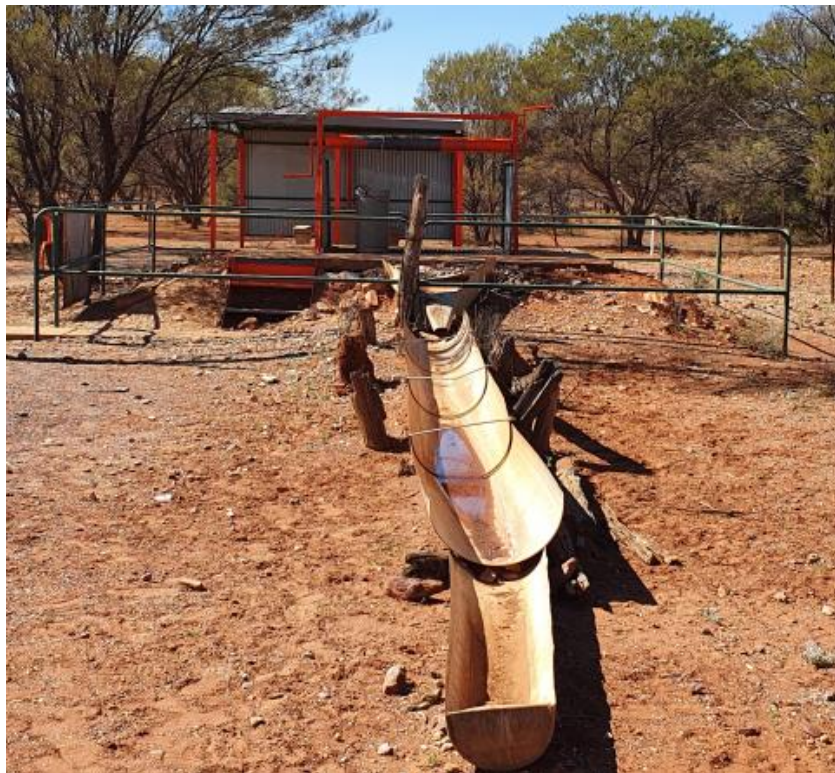
Well 5

Restored in good repair. Covered shelter & picnic bench, large camp area, gravel/stone base, track to Granite Peaks not well sign posted

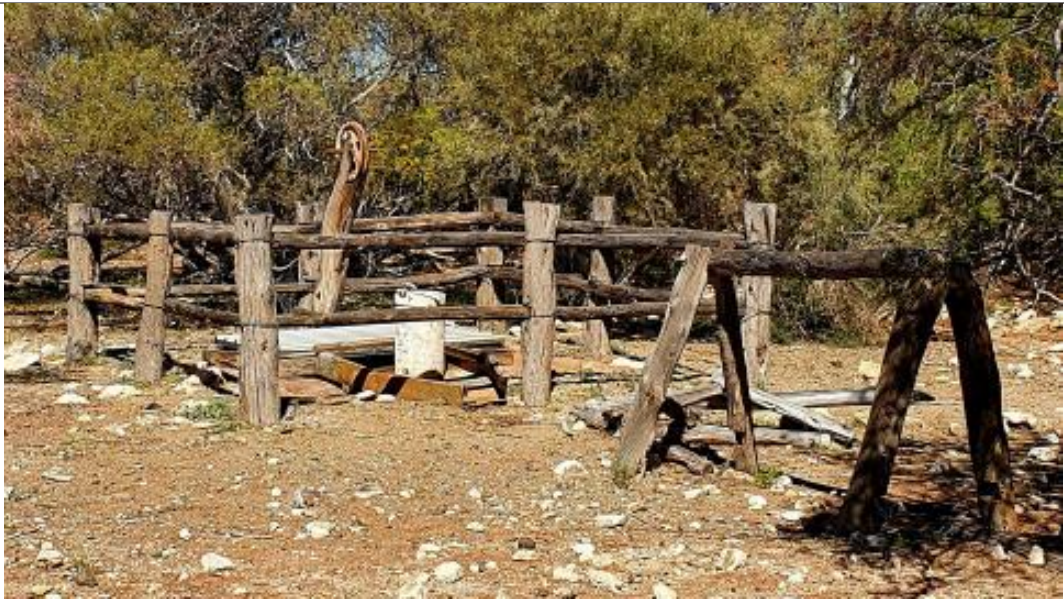
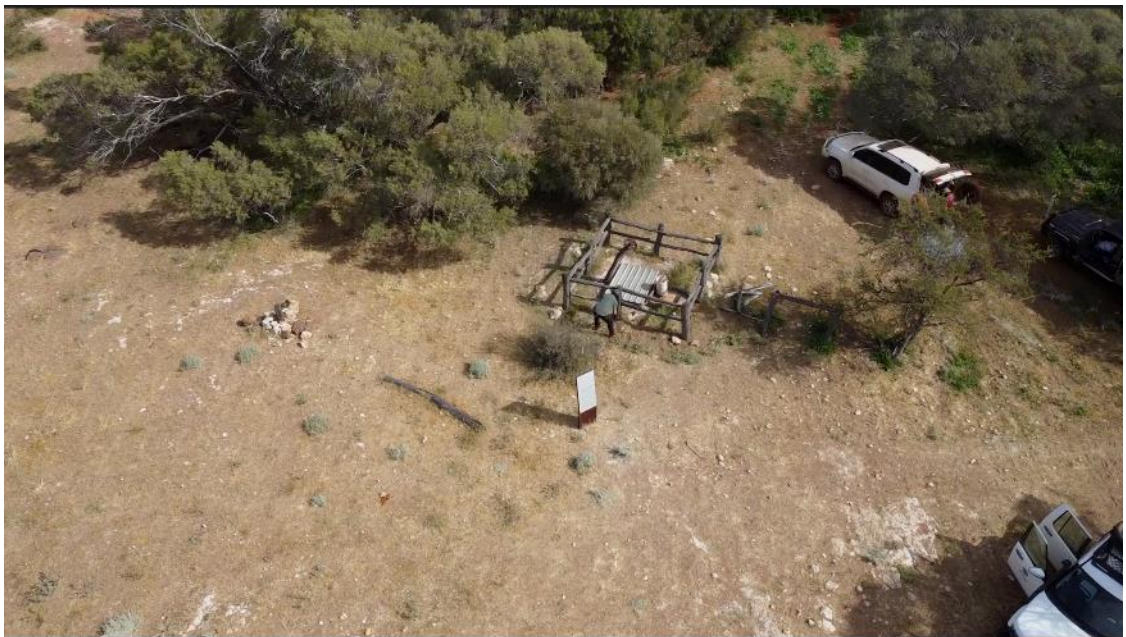
Well 9 Palatji, Weld Spring Lat. -25.017402 Long. 121.586342

Restored but in fair condition. Water is good. No cable for bucket. Covered over, bore & tank for cattle, John Forrest's Hut, information display shelter, large flat area, Ground/sand base, Paperbark and scrubby area.

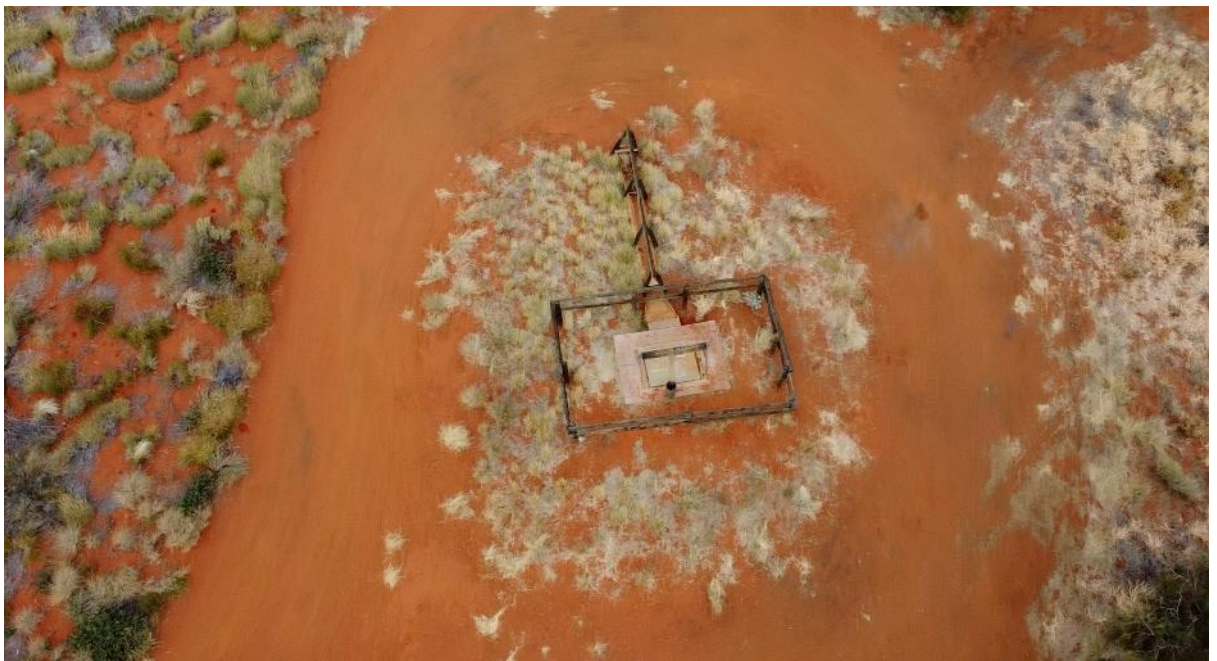
Well 12

Restored, in good repair. Toilet in good condition, toilet signs ok, drums used as signage, need new solar light, good camp site, Desert Oaks, ground sand based.

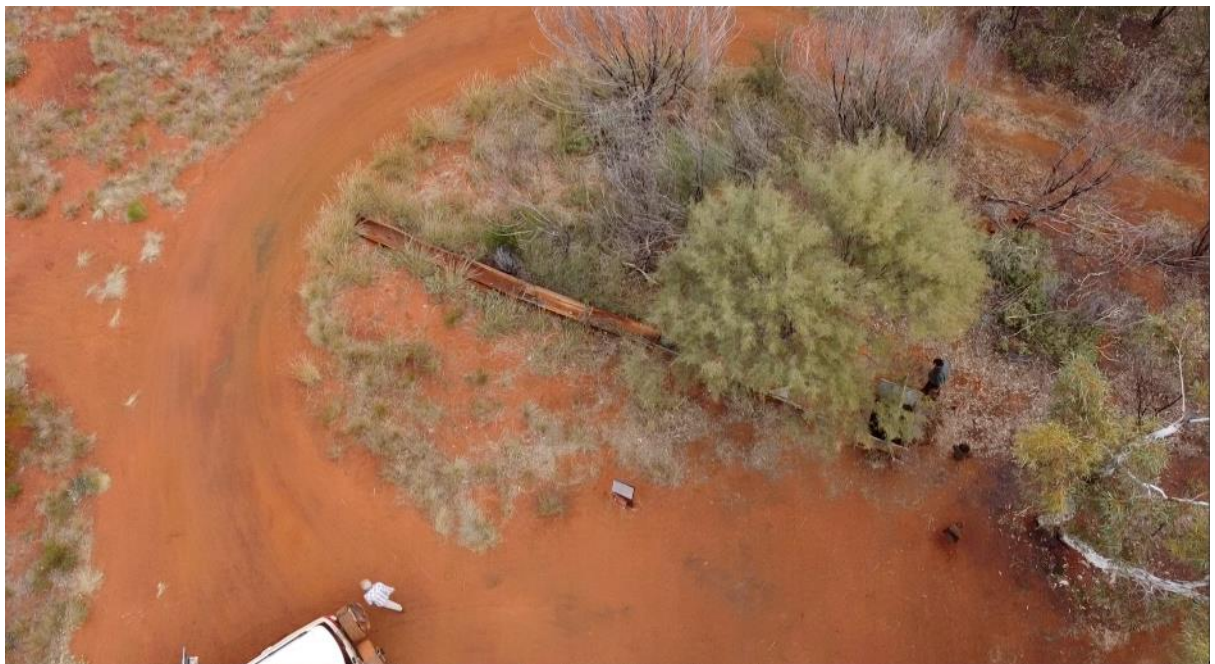
Well 15, Manjanka

Restored. In good repair, plenty of water, toilet in good repair, toilet signs in good condition, unknown working condition of solar light, good camp area.

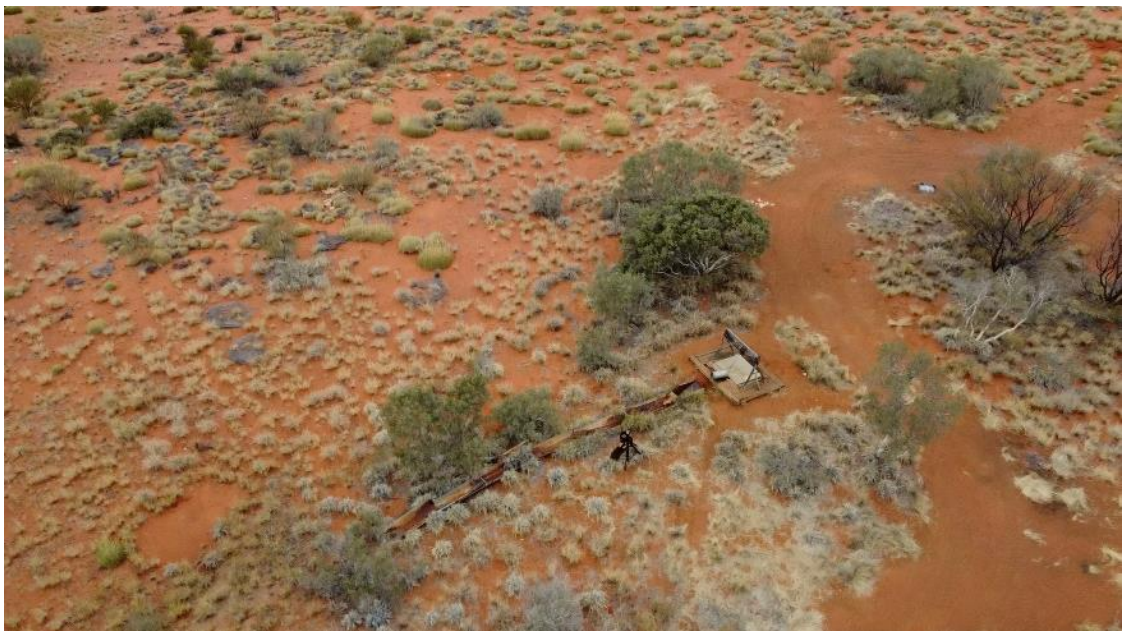
Well 18, Wanykuju

Restored, in good repair, top well boards badly damaged from termites, scrub, little shade, only small area to camp. Water slightly salty.

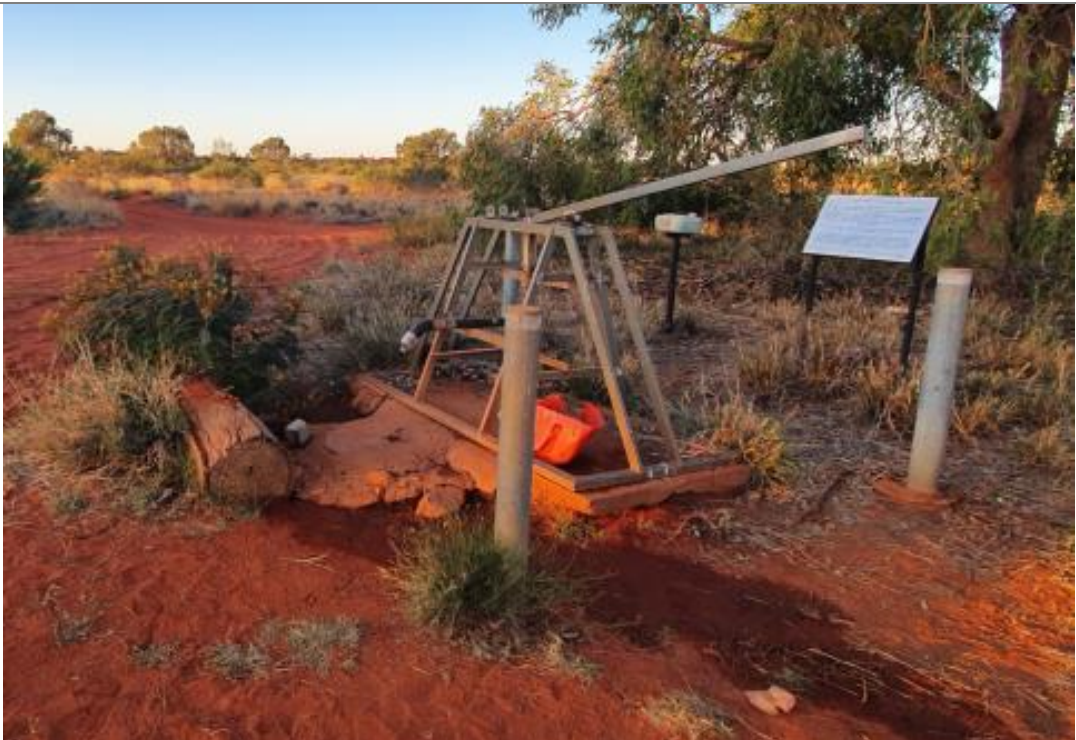
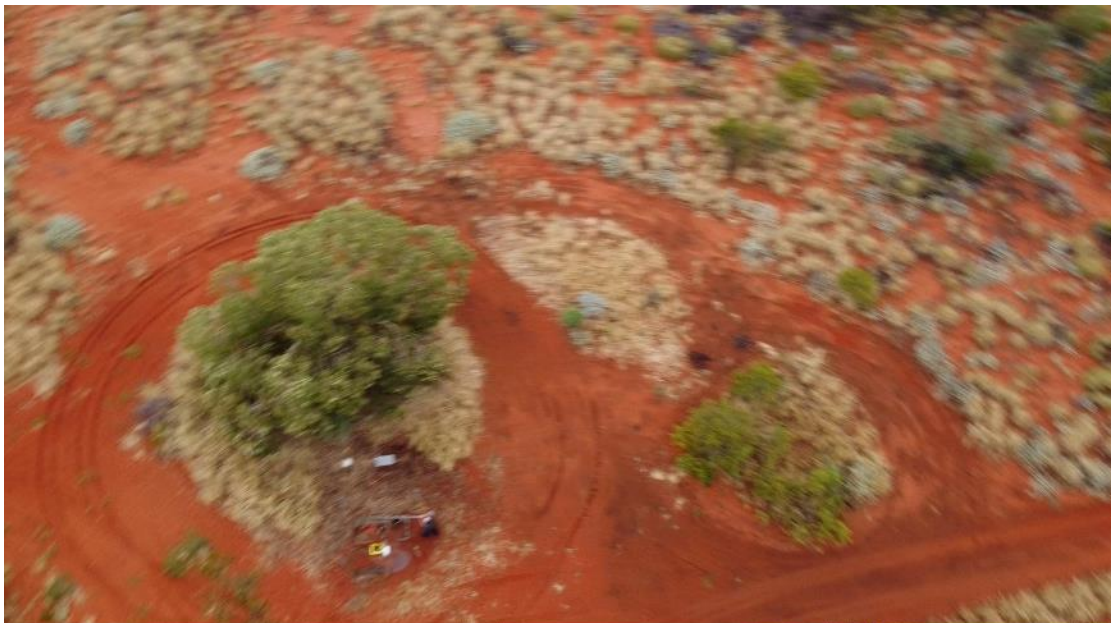
Georgia Bore

Site has many camping spots, a good bore water supply and toilet. Enviro toilet tank in place next to current toilet but use unknown. 1x BBQ destroyed, 2x BBQ in good repair,

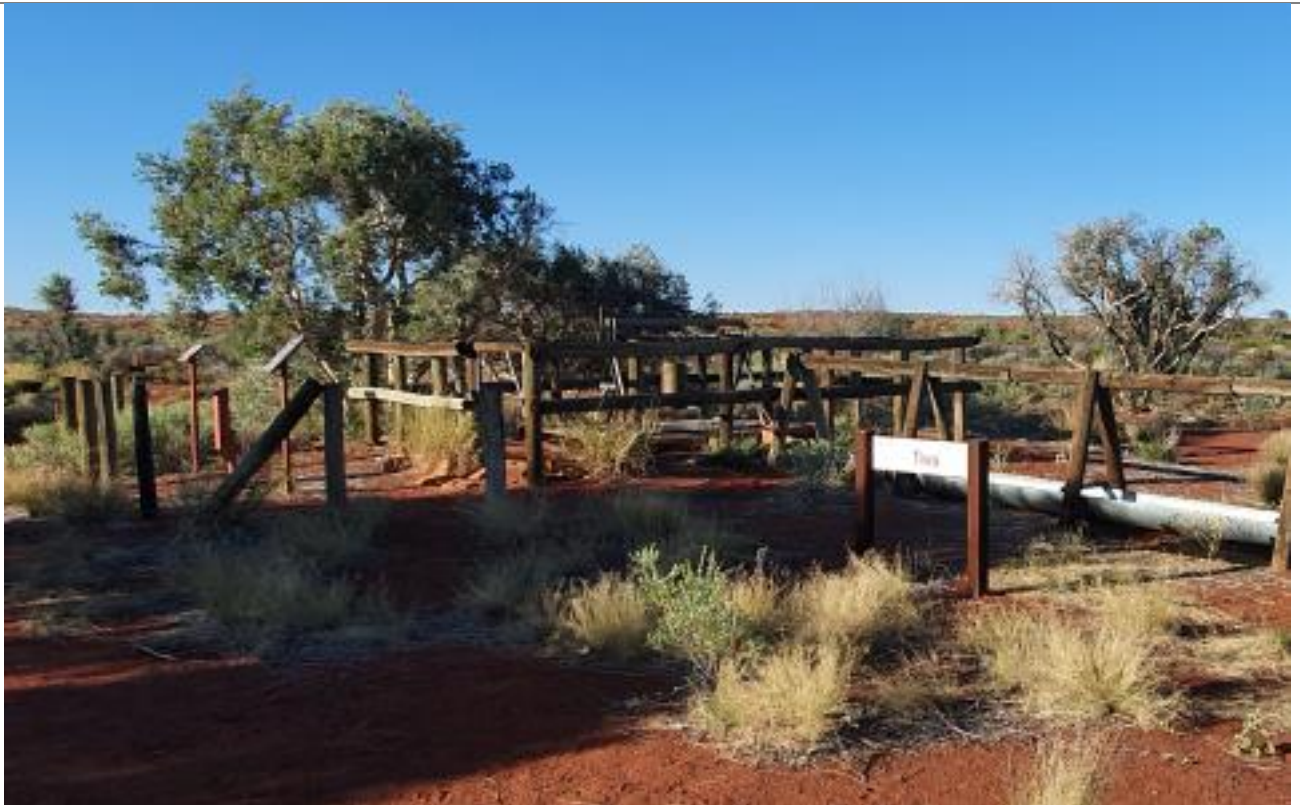
Well 26, Tiwa

Restored, well in good order, boards damaged by termites, post near well gate dislodged out of ground, toilet in good repair, waste signs damaged & unreadable, dump point relocated, Solar light working, waste sign requires relocating, TCWA & other signs on well unreadable, TCWA repair sign rusted & almost unreadable & hidden by grass. Camping area sign obscured by growth & also not visible from southerly track, designated camping area appears rarely used in favour of immediate well area. Visitor book stand broken & leaning over.

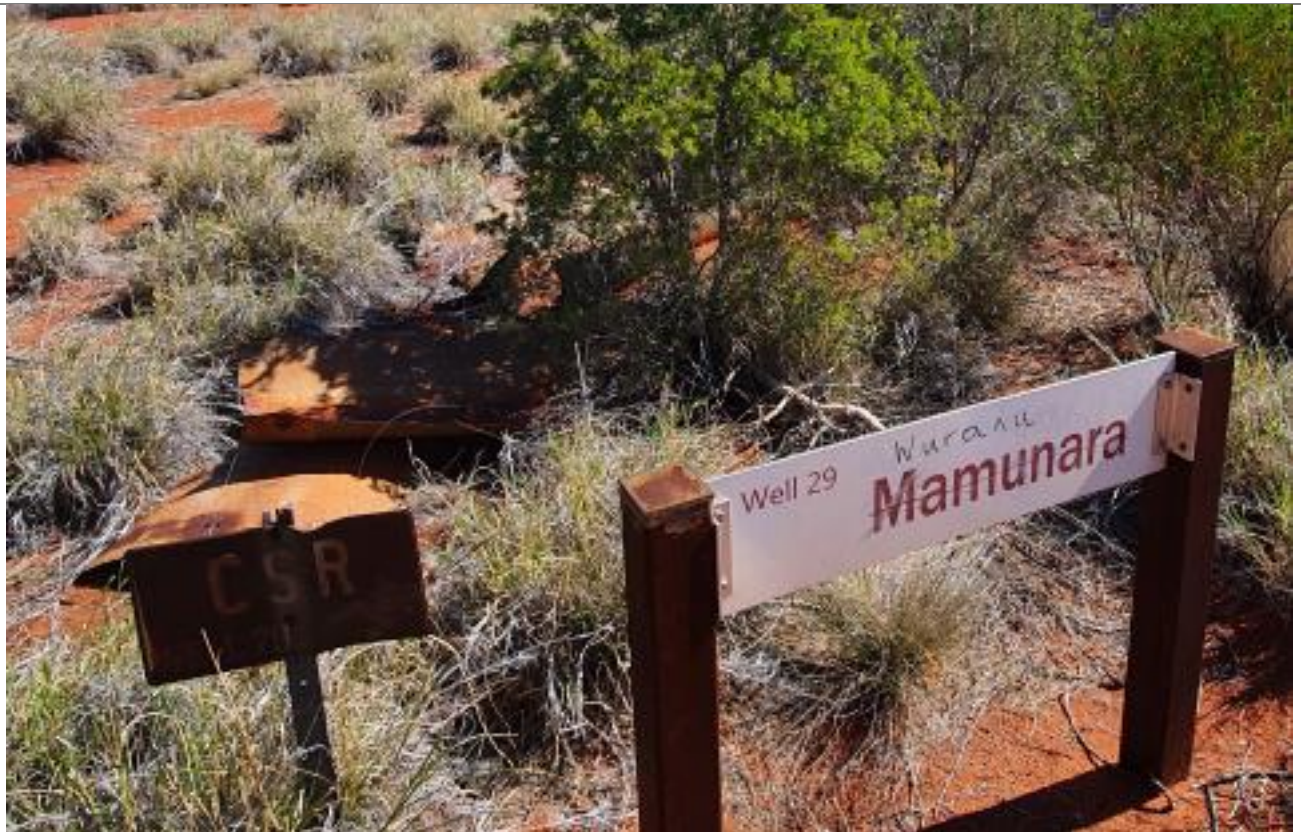
Well 29, Mamunara**Lat. -22.554742****Long. 123.879116**

Unmaintained, filled in. CSR sign in poor repair rusty & barely readable, very small area.

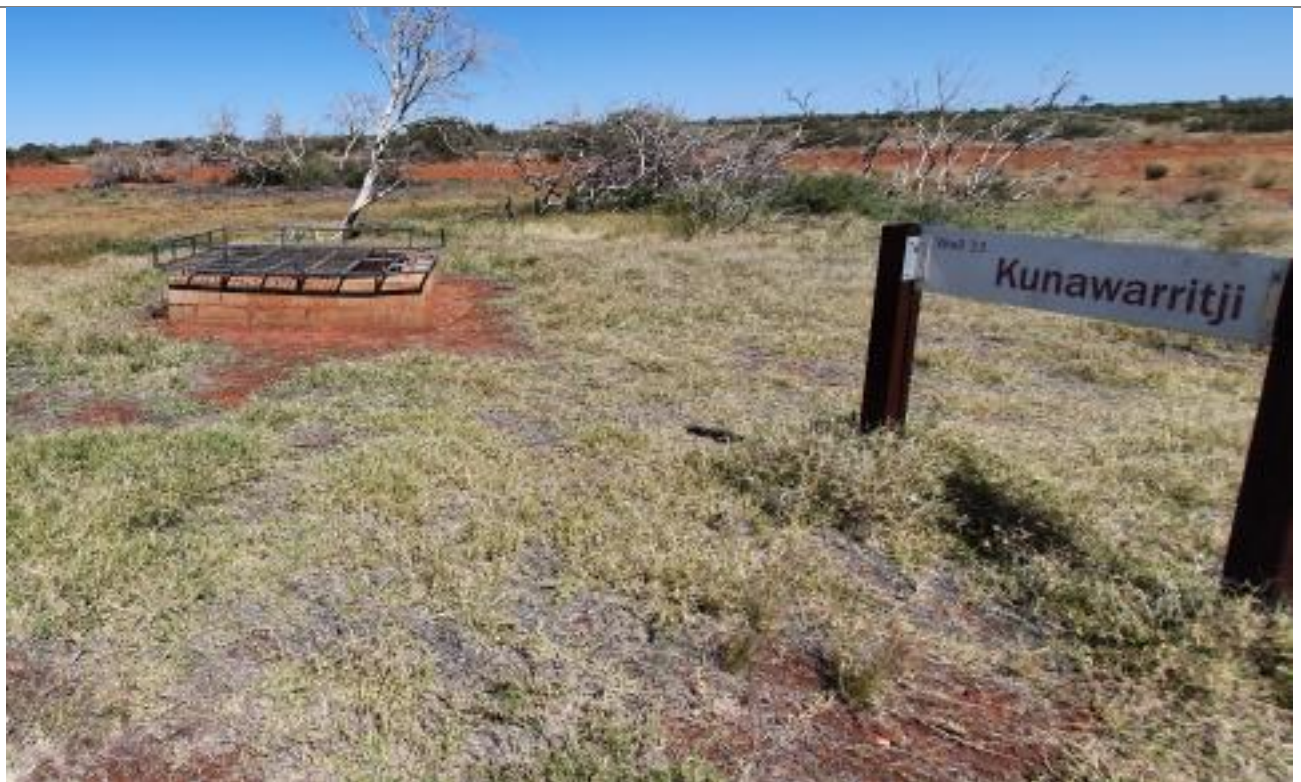
Well 33, Kunawarritji,**Lat. -22.341465****Long. 124.775219**

Well covered with metal rack, good bore water from tank, Toilet in good repair, solar light working. Waste dump point relocated to community waste site, requires new waste dump point sign, Large open exposed camp area, medium vegetation around perimeter.

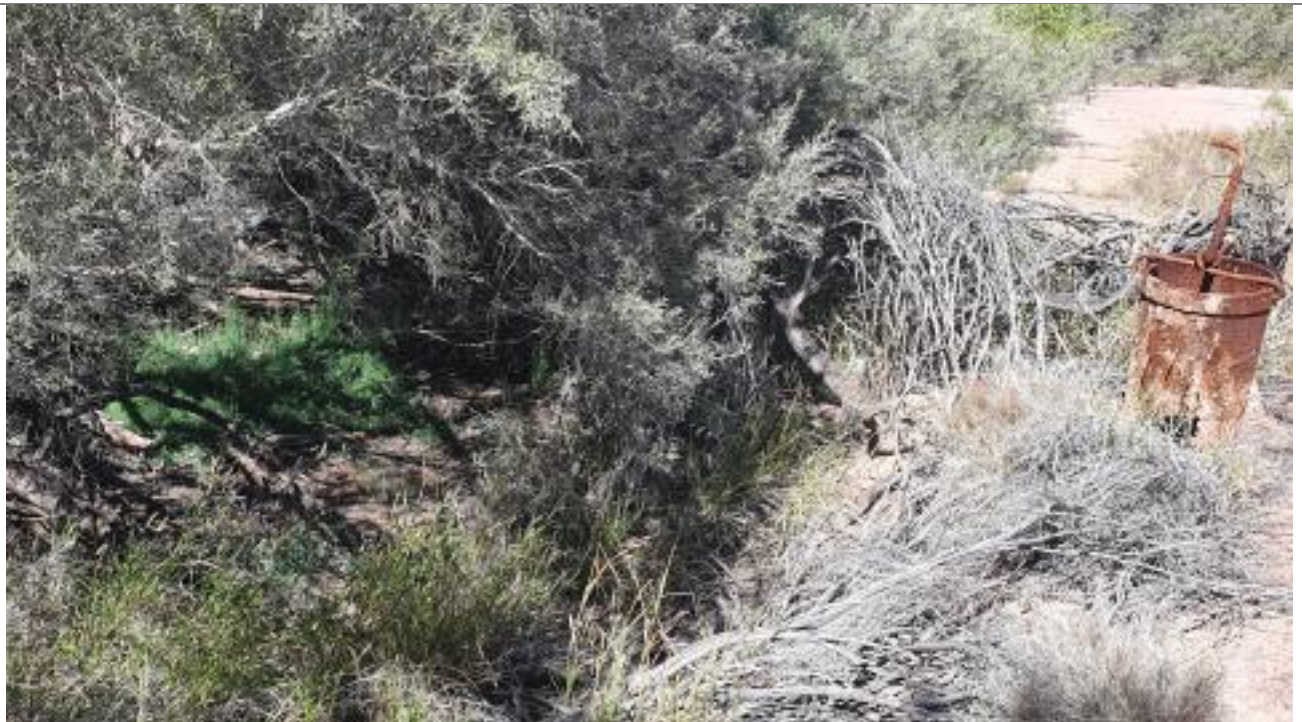
Well 35, Kinyu,**Lat. -22.213178****Long. 125.050668**

Unmaintained, dry, Poly pipe bore not found, good camp area, Buffel grass, sand base.

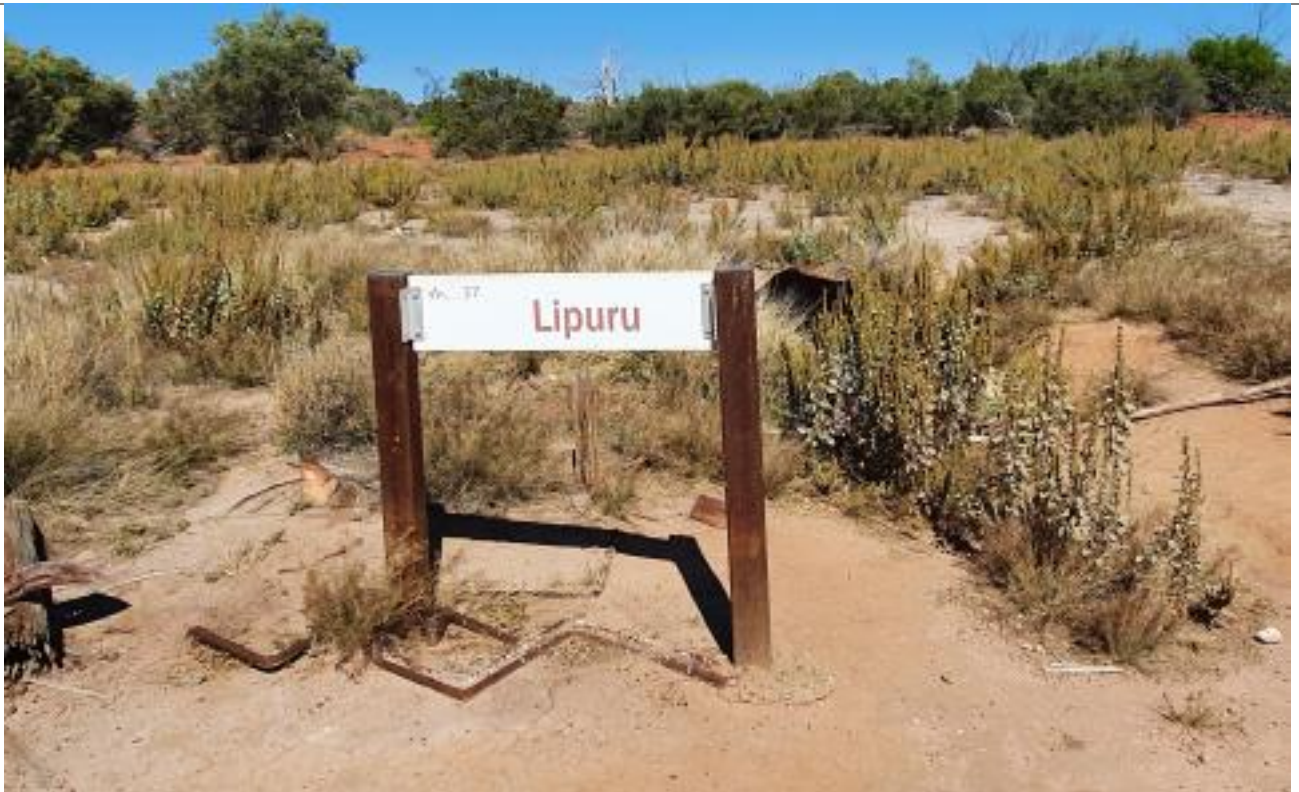
Well 37, Lipuru,

Unmaintained, dry. Well covered with section wire fence, Buffel grass, sand base, Replica of original grave markers in poor state of repair, Thompson, Shoemith & Chinaman graves not found.

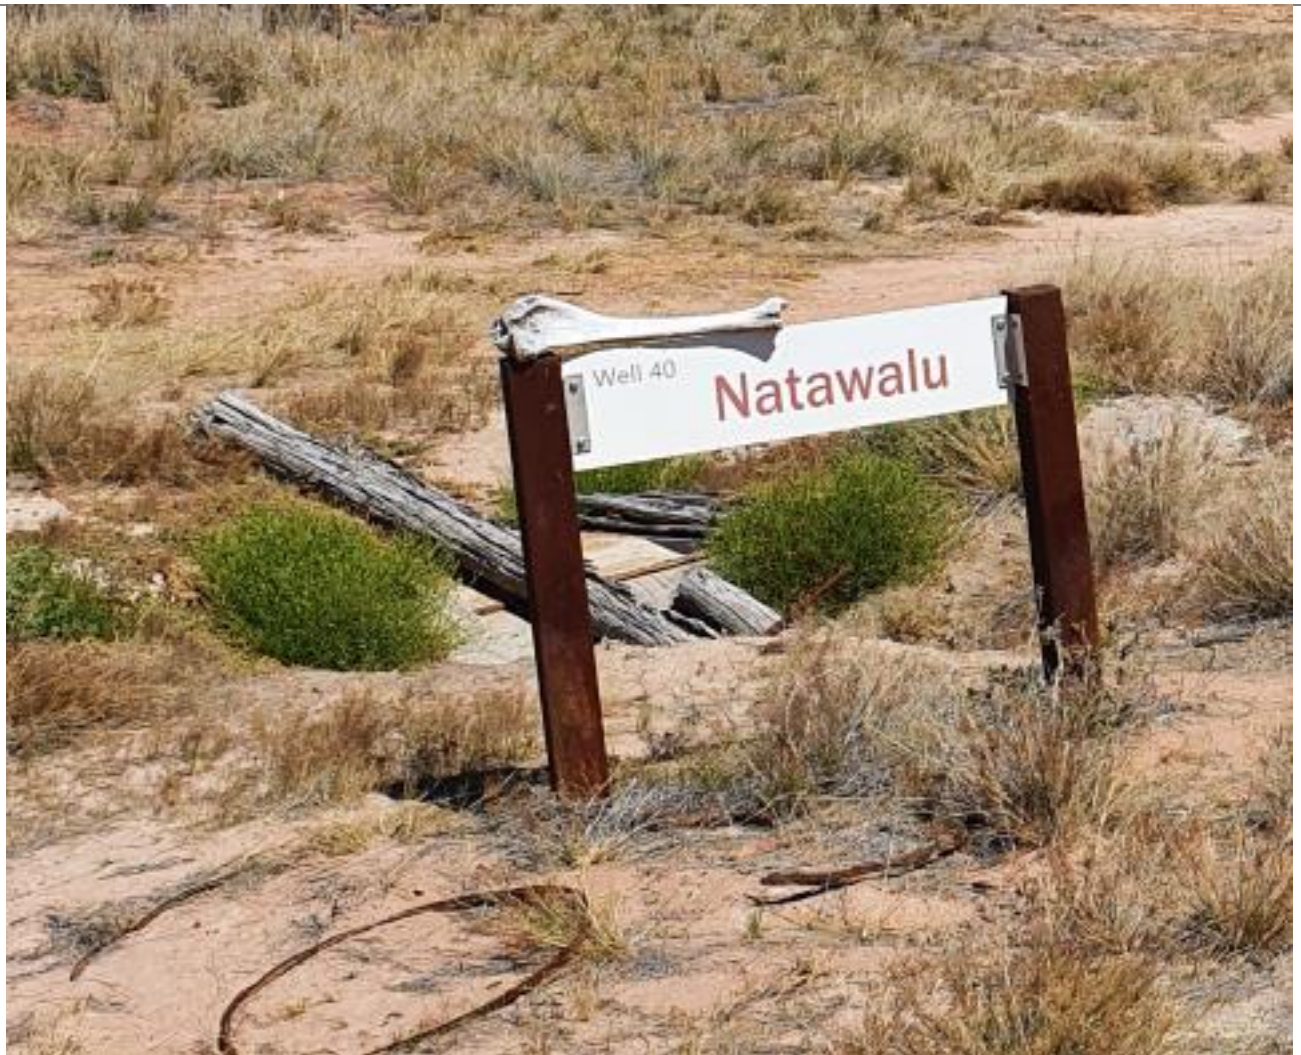
Well 40, Natawalu,

Unmaintained, dry. Well opening covered with timber/ply sheets, Signage on rusty cattle trough barely readable, very small area, low scrub. Graves of Michael Tobin & Mungkututu nearby in good condition.
