Canning Stock Route Audit Report

Prepared for Track Care WA
Author: Rod Durston
August 2022
Revised June 2023

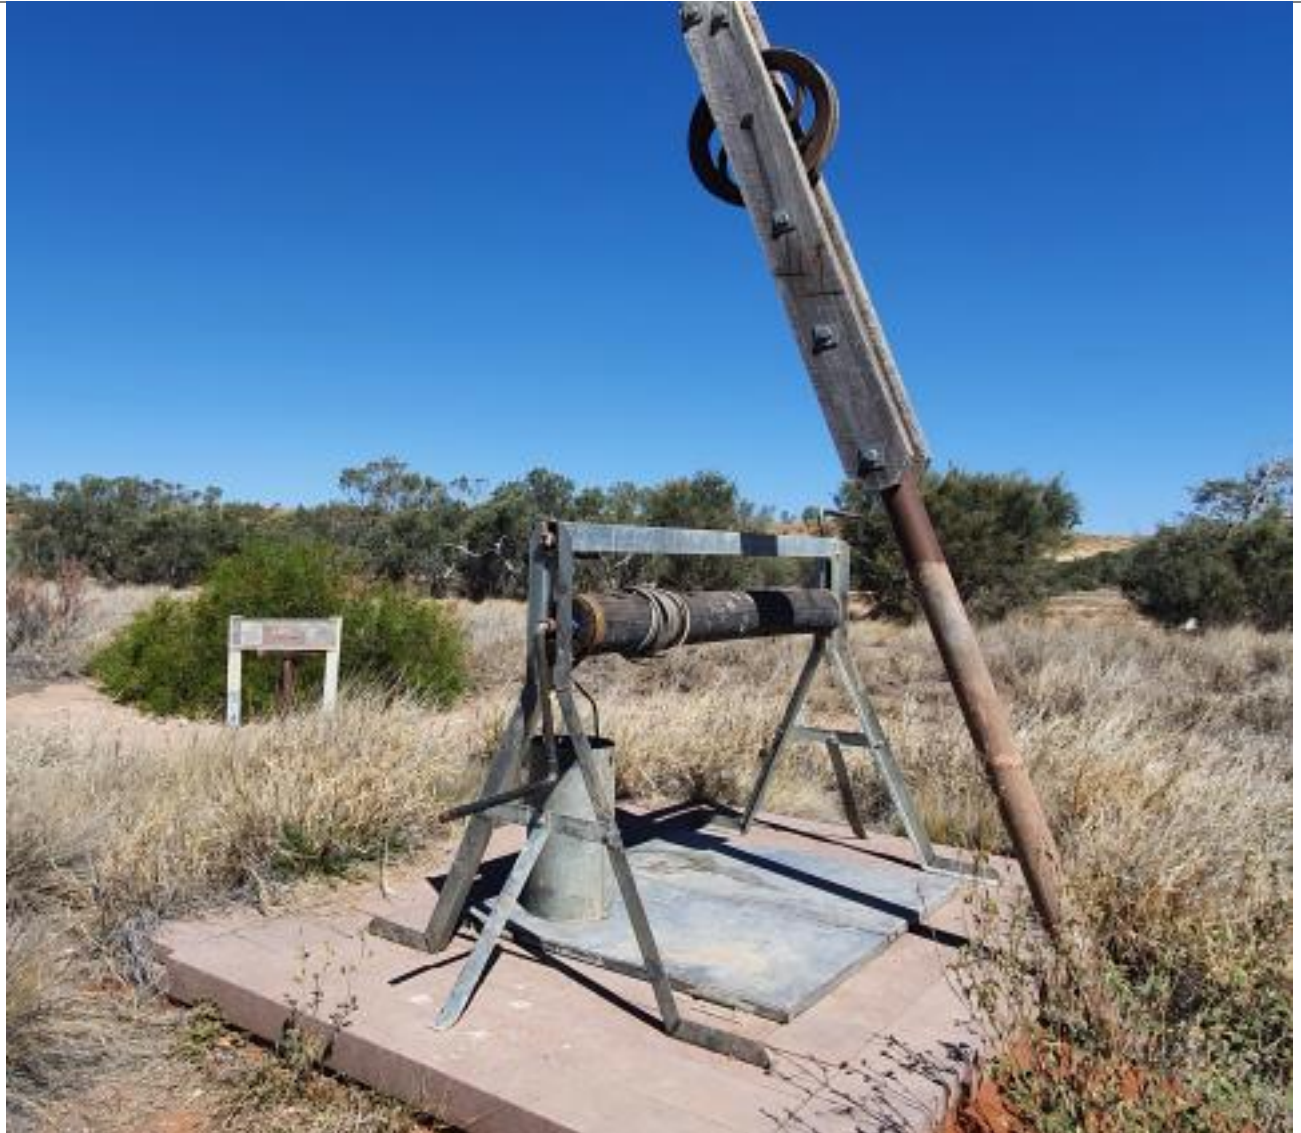
Well 41, Tiru,

Well in good repair. Toilet in good repair, toilet signs in good repair, waste dump point relocated to salt pan, new direction sign required, toilet direction sign created on steel drum, no visible solar light, toilet pathway cleared, small camp area very exposed.

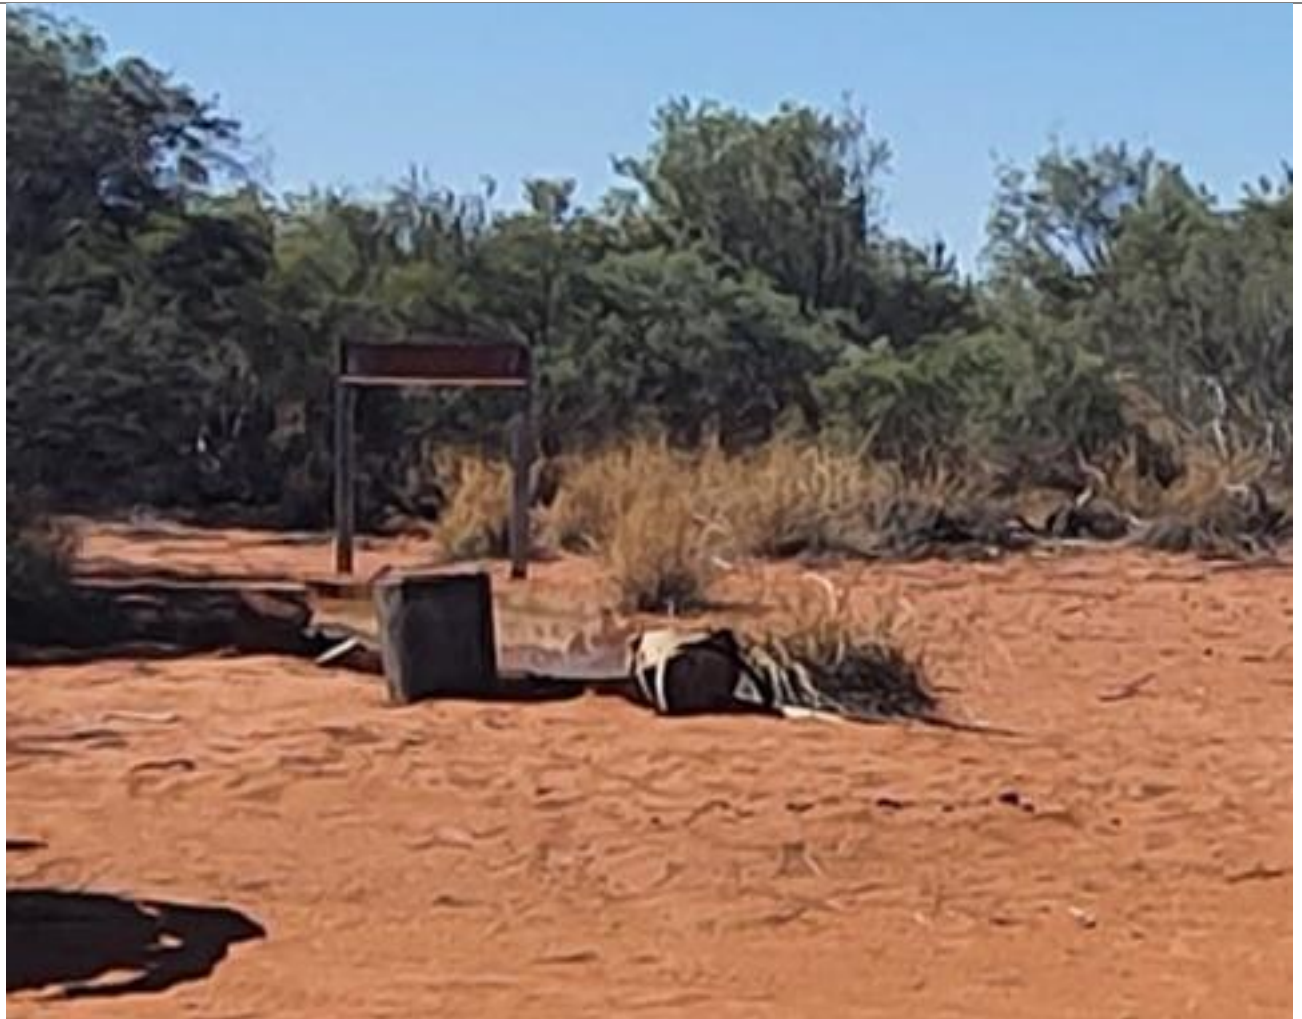
Well 43, Katajikka**Lat. -21.212815****Long. 125.973336**

Unmaintained, filled in. Signage poor (scratched on old rusty drum), small/med size camp area, sandy, Buffel grass.

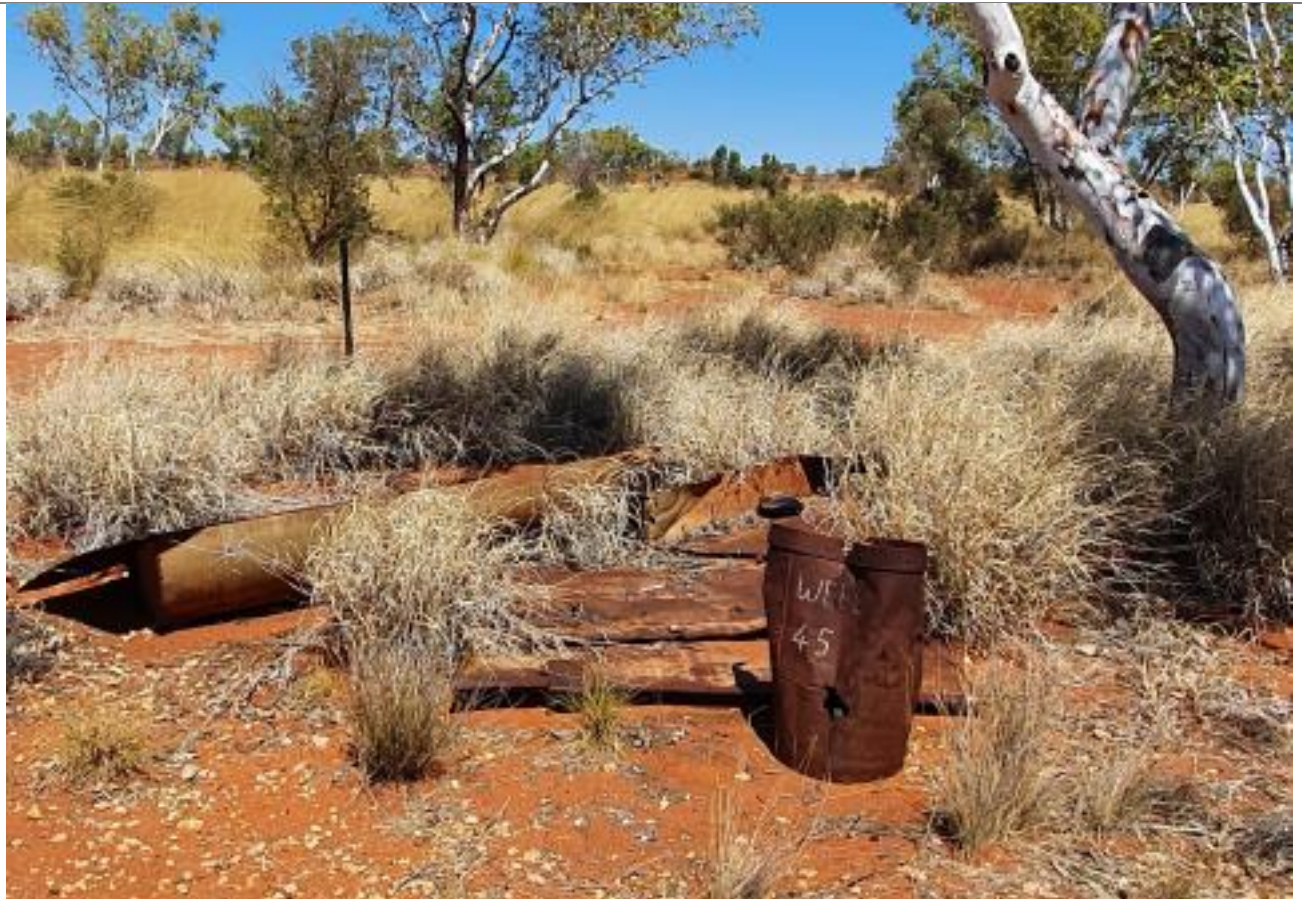
Well 45, Jintijinti

Unmaintained, filled in. Signage very poor (scratched on rusted bucket), small open area to camp, low trees, little shade, sand base, Buffel grass.

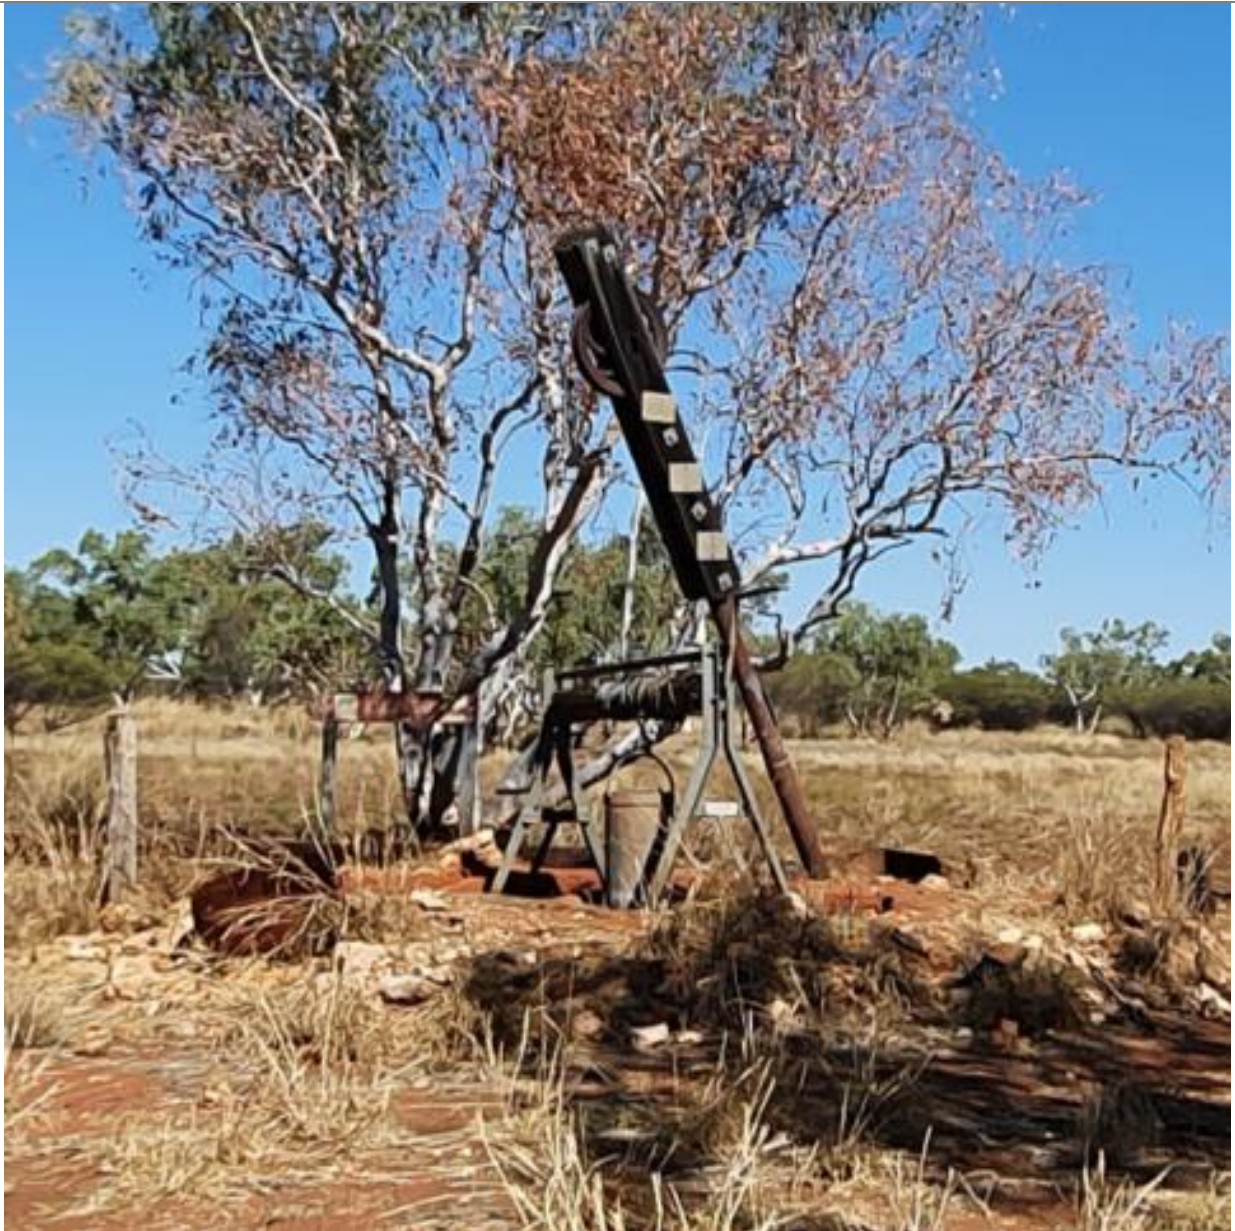
Well 46, Kuduarra**Lat. -20.641777 Long.126.287671**

Well in poor state of repair due to fire. Windlass & bucket in good condition, (steel) whip pole in good condition. Temporary repair of a Ute tray used to cover open well, windlass secured to top of tray. Burnt rubbish strewn around, bottles & cans in burnt heap, signage burnt. x2 fire pits (cut barrel) submerged in soil. Toilet in good state of repair, waste sign in good condition, solar light working. Large area to camp, ground base, few trees, low scrub, little or no shade.

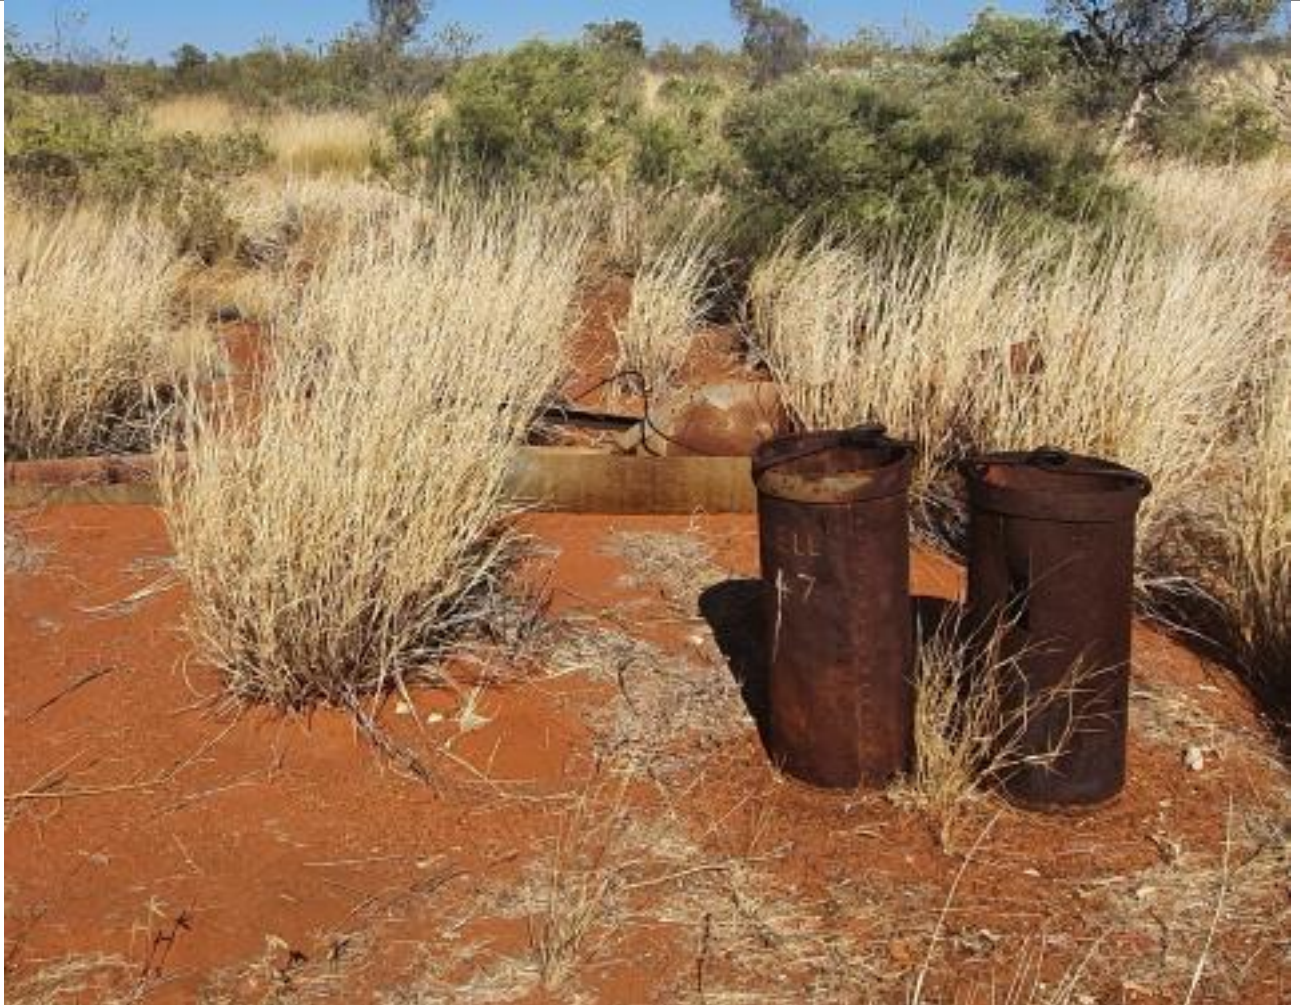
Well 47, Kartalapuru

Unmaintained, filled in. Signage poor (scratched on rusted bucket) plus small metal sign stamped 47. Very small, exposed area to camp, sand base, Buffel grass.

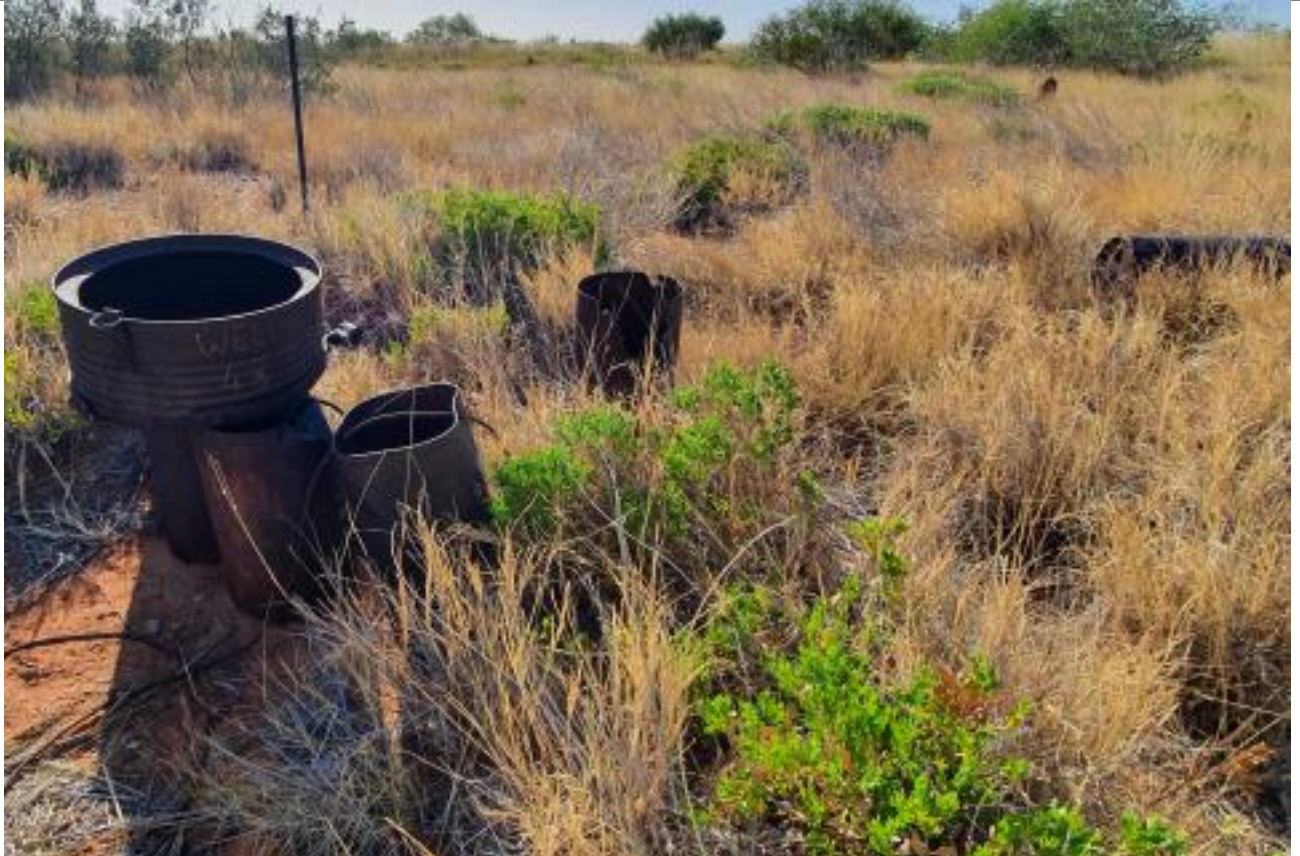
Well 48, Kaningarra

Unmaintained, Filled in. Signage v poor (faint scratched on rusty drum), Very small, exposed area, sand base, Buffel grass.

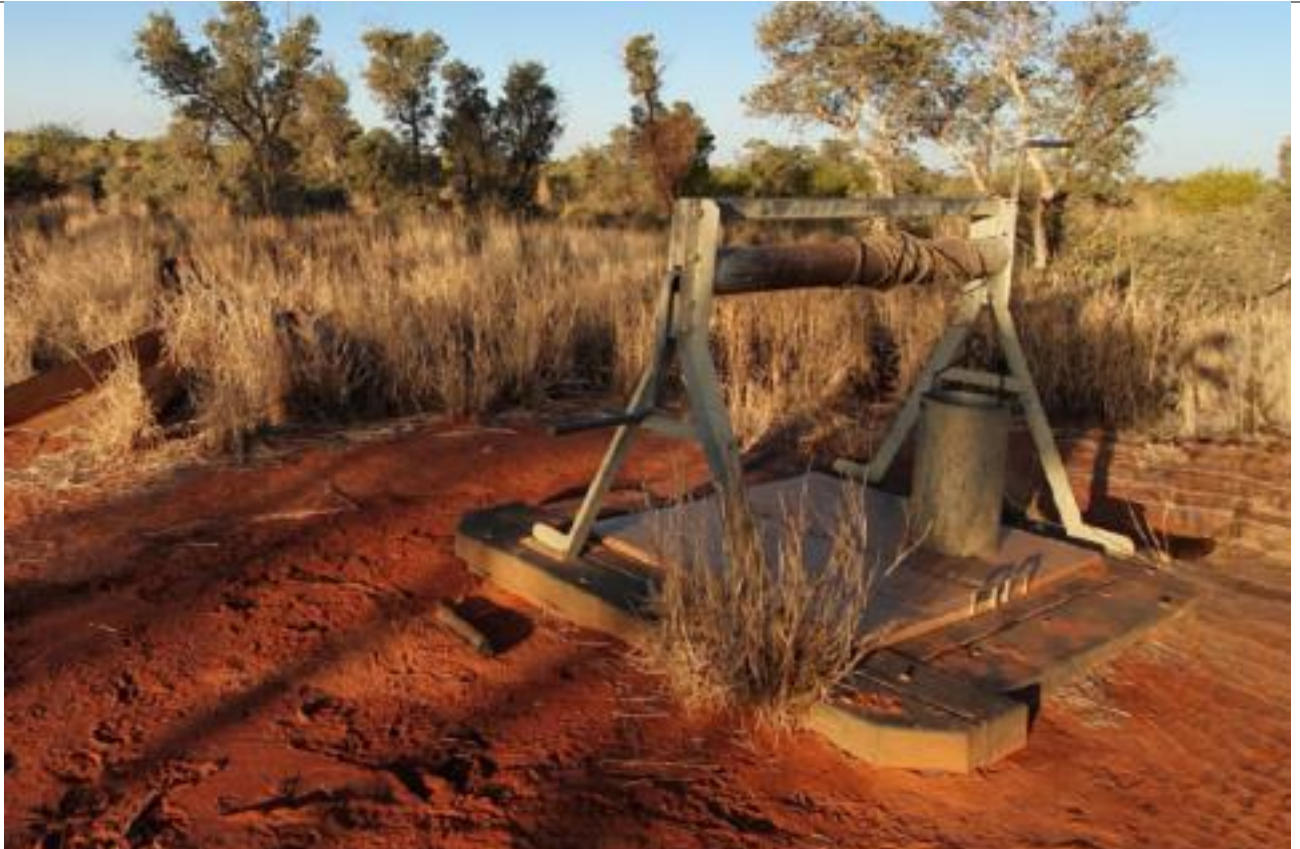
Well 49, Lampa**Lat. -20.164220****Long. 126.681277**

Well in good repair. Ranger's station, double toilet in good repair, no solar light, trailer tyre to be renewed. Waste dump point heavily overgrown, alternate dump site to be found. Small camp area, sand base, low trees/scrub, Buffel grass.

Some of the toilet trailer tyres at Derba Springs and Well 49 needs replacing and the toilet at Lake Stretch is in a dangerous state due to termite damage. At the time of writing it's unknown who

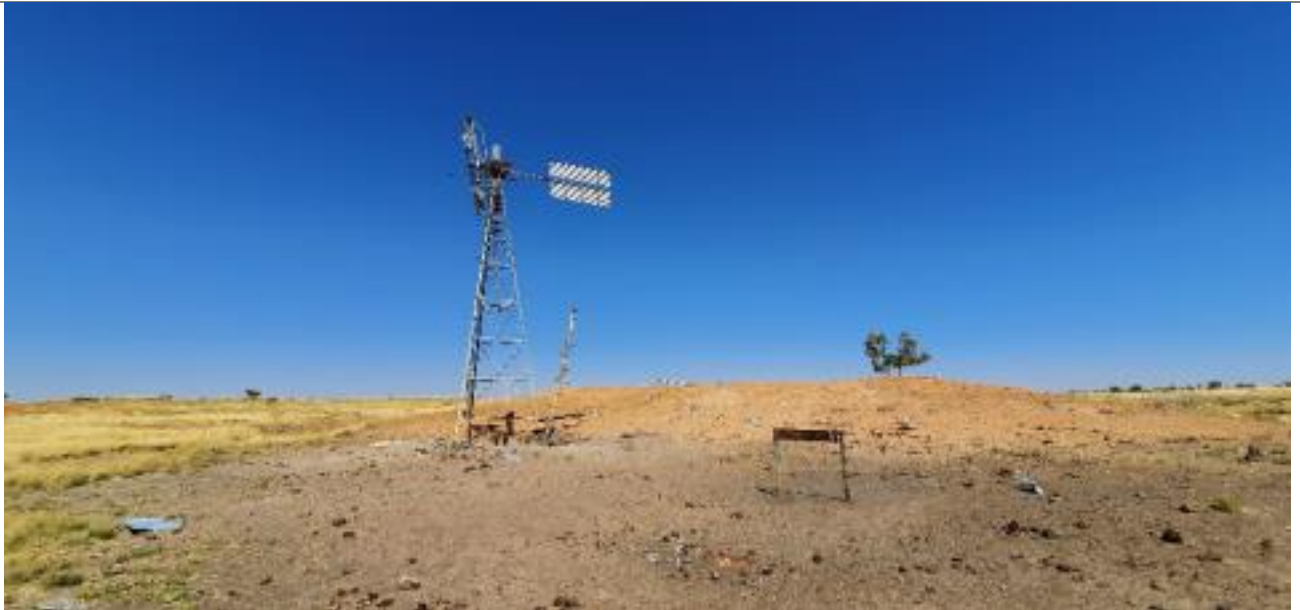
Well 51, Wirrijarra**Lat. -20.147733****Long. 127.146307**

Unmaintained, filled in and windmill severely damaged. Open & exposed.

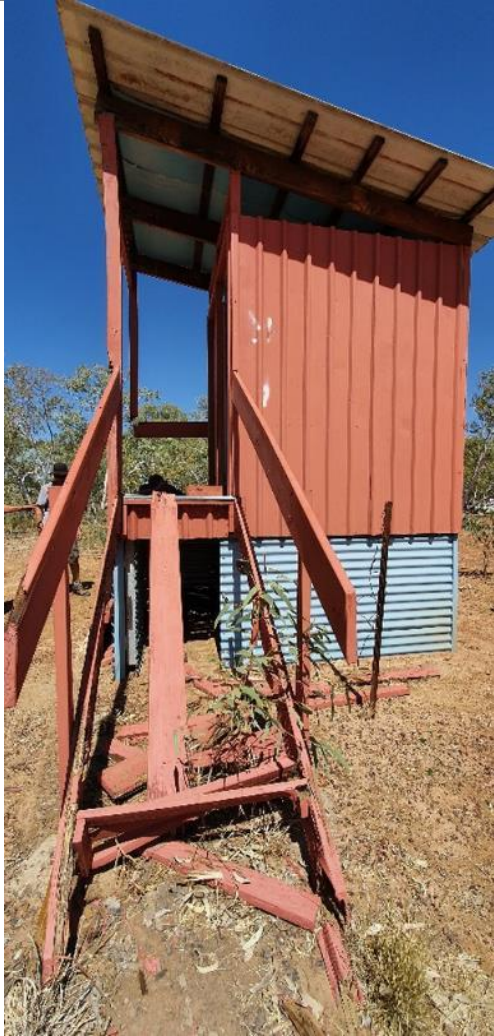
Structure has significant termite damage and is in a dangerous condition. Composting bin and pedestals seem to be ok. Solar system present but unknown use or condition.

constructed this toilet and therefore who should repair it. It will be a major project to complete as it requires a complete rebuild. Apart from some minor repairs undertaken, in general the toilets are in good condition there does not seem a need for extra toilets along the CSR.
