Canning Stock Route Audit Report

Prepared for Track Care WA
Author: Rod Durston
August 2022
Revised June 2023

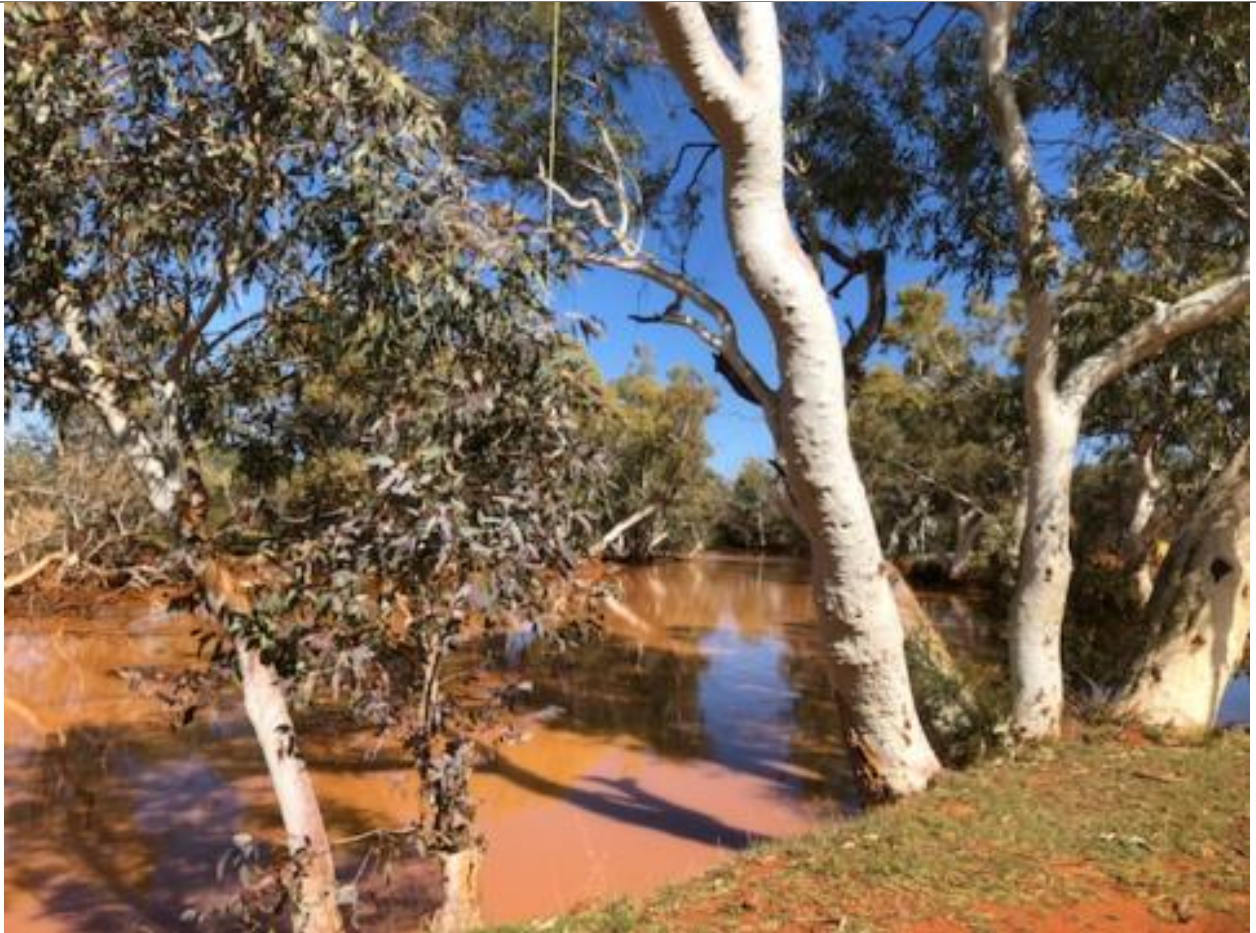
Multiple camp areas, large pool, waste bins, level area, White Gums, scenic.

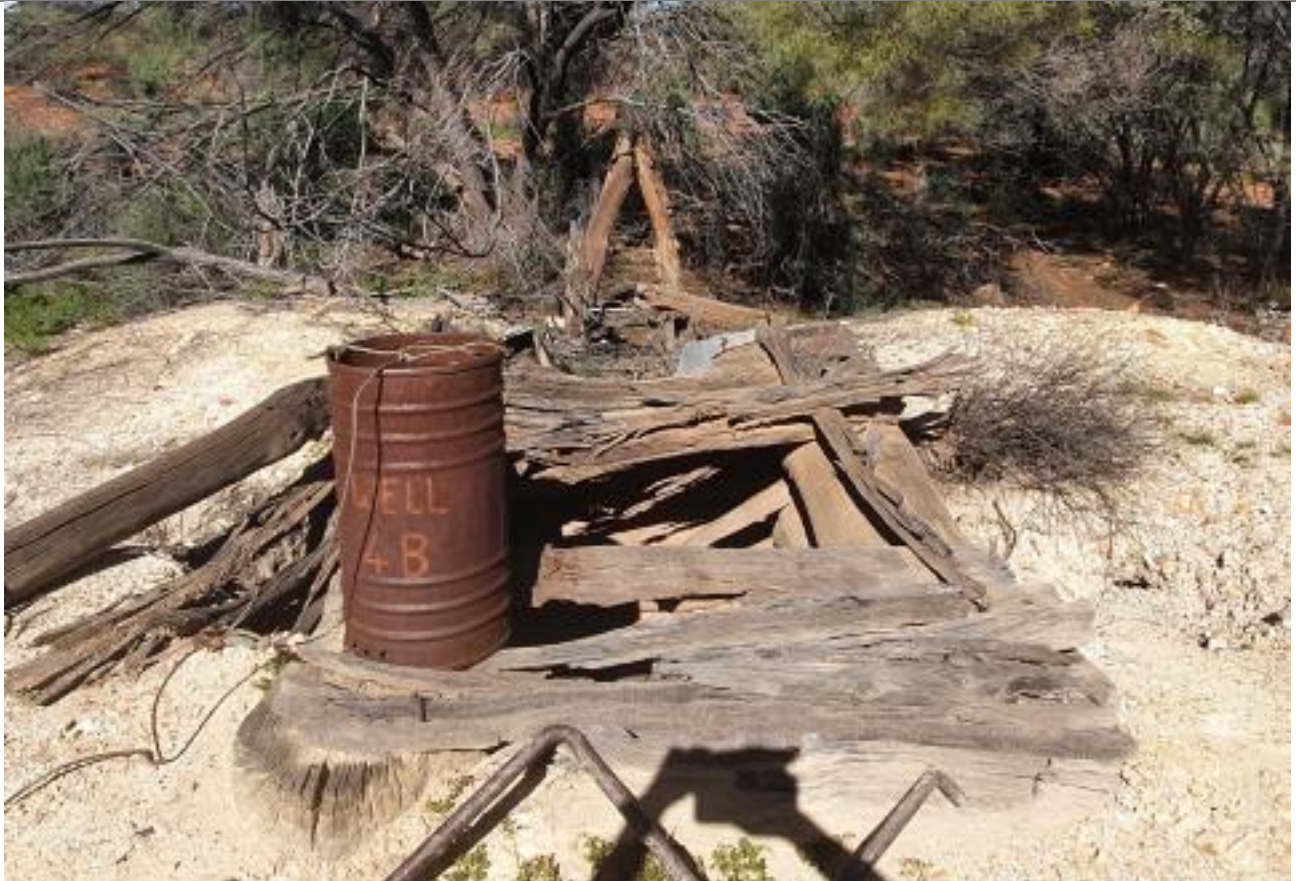
Unmaintained with timbers covering well.

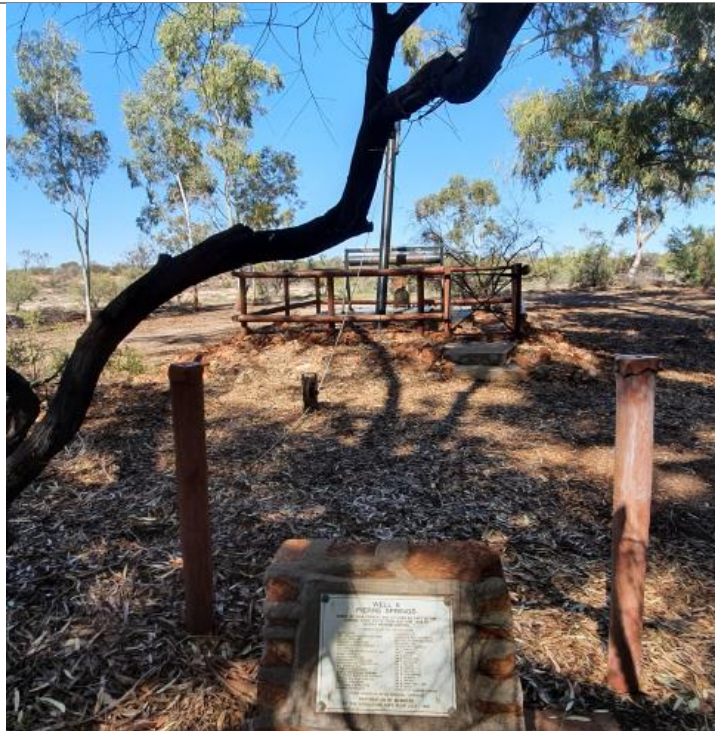
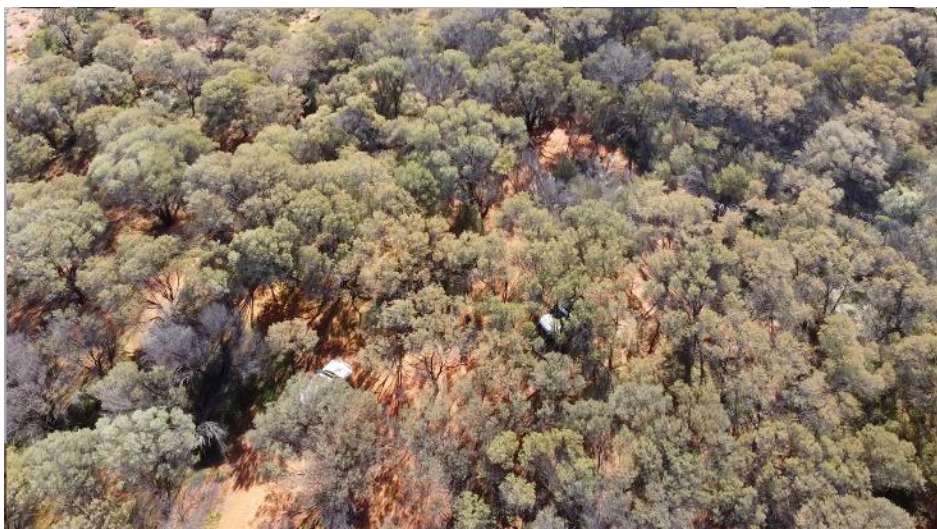
Well 6, Milyinyiri, Pierre Spring **Lat. -25.240808** **Long. 121.099399**

Restored, in good repair, toilet in good repair, BBQ x1 very rusted at base, x2 additional fire pits, heavy shade from large white gums, leafy/ground base, Caltrop weed on track to dunny and surrounding scrub.

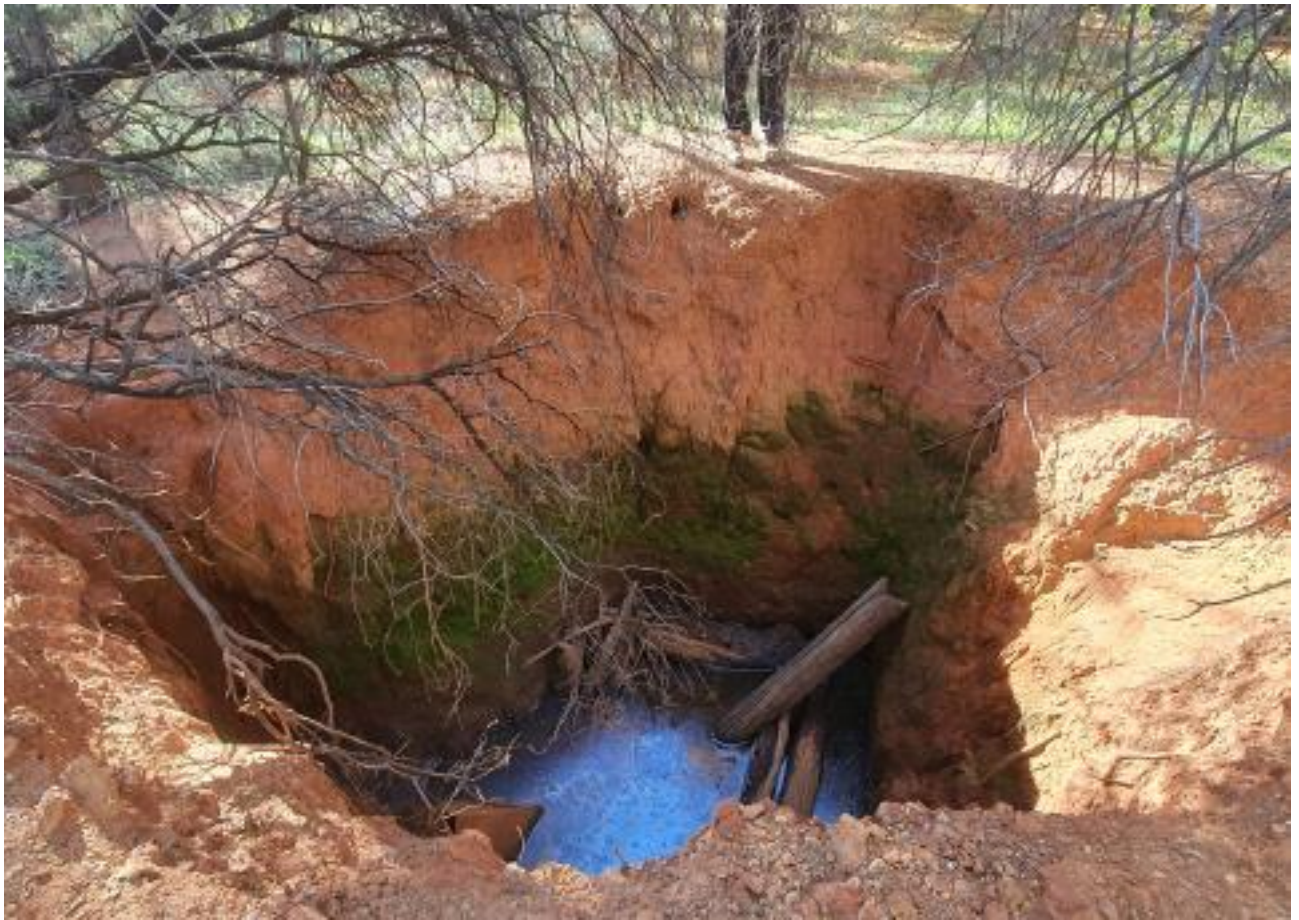
Unmaintained, good camp area, low tree cover providing ample shade.

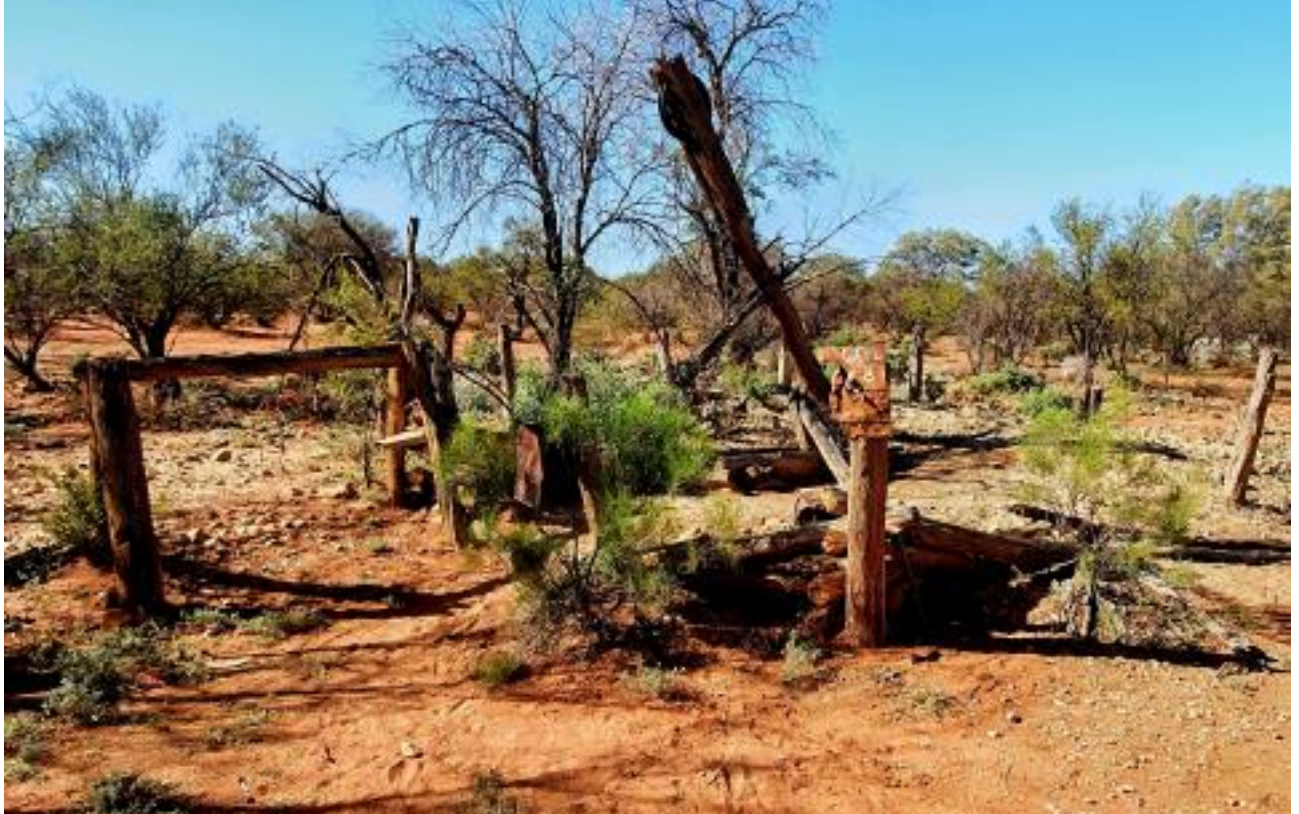
Unmaintained. Camp area, partial shade, low trees/scrub, Ground sand based.

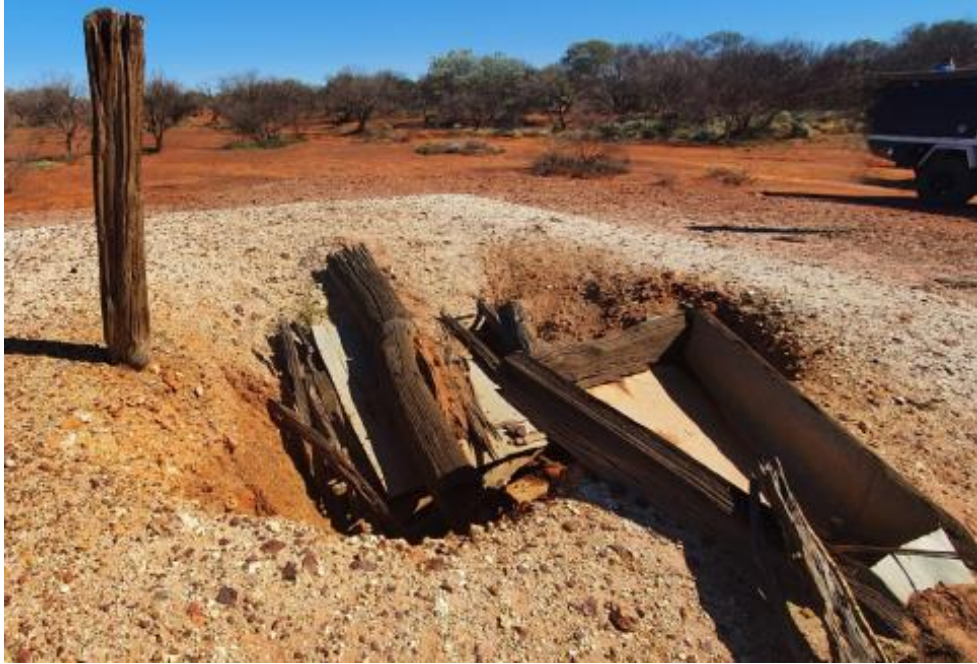
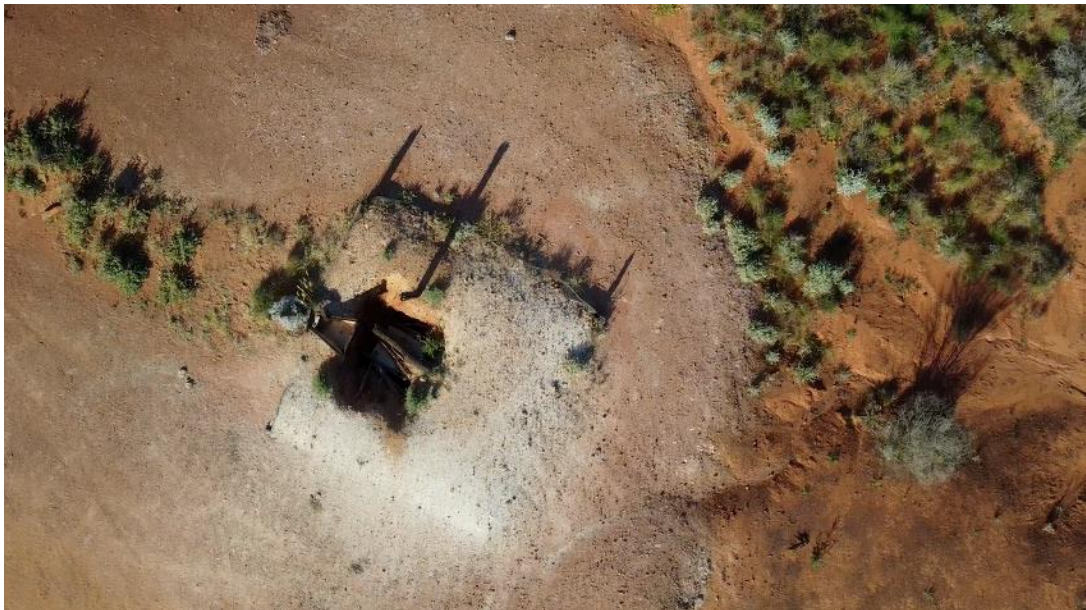
Unmaintained, little shade, large flat area, medium wetland on edge of area, sand based.

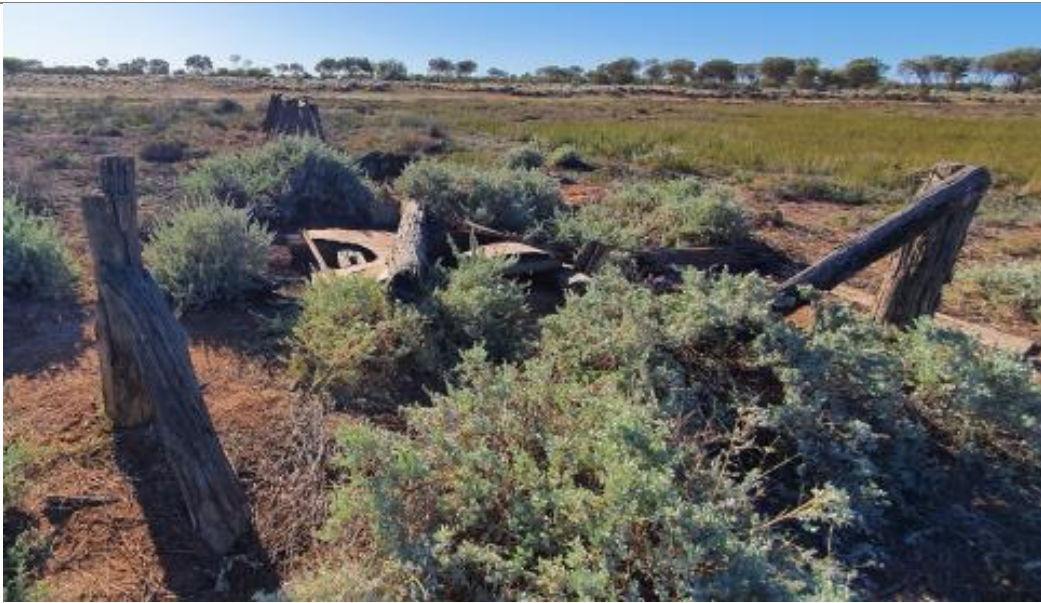
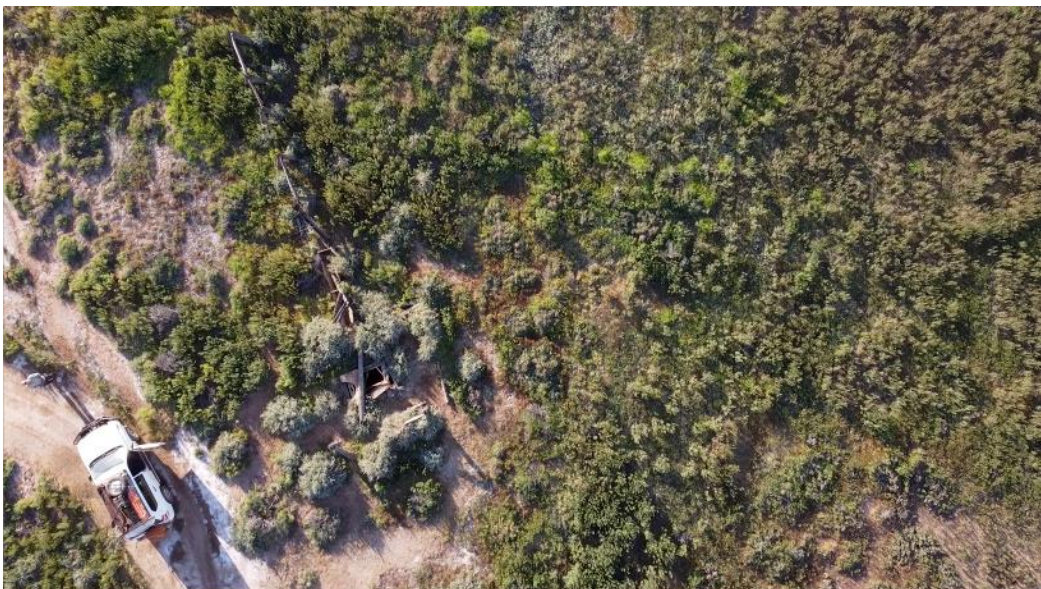
Well 11 Panju, Goodwin Soak, Lat. -24.749184 Long. 121.733995

Unmaintained. Notice to travellers sign unreadable, large area to camp, very open, no tree coverage in well area.

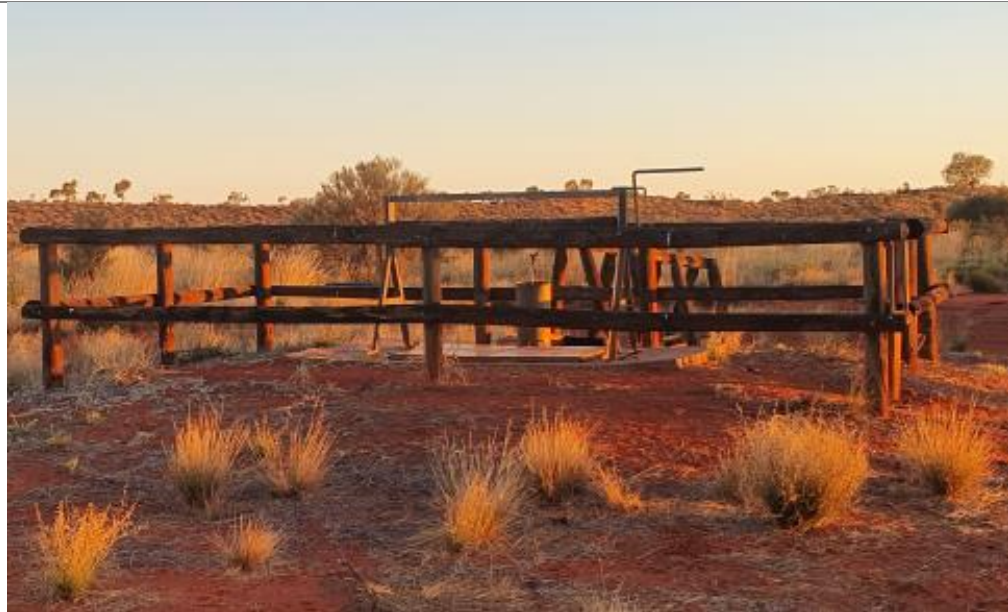
Well 12

Restored, in good repair. Toilet in good condition, toilet signs ok, drums used as signage, need new solar light, good camp site, Desert Oaks, ground sand based.

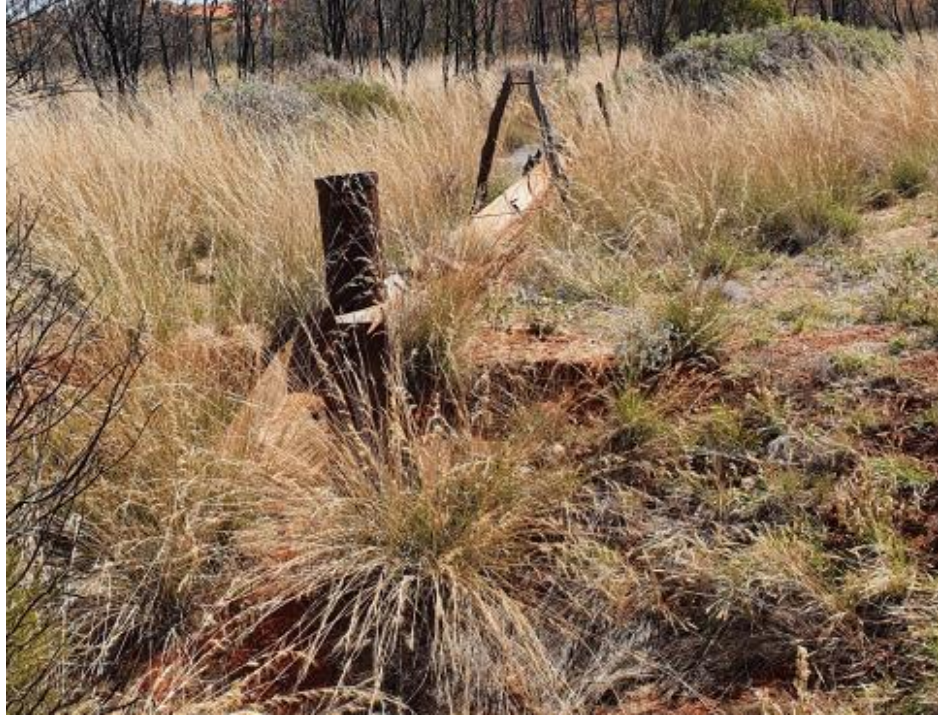
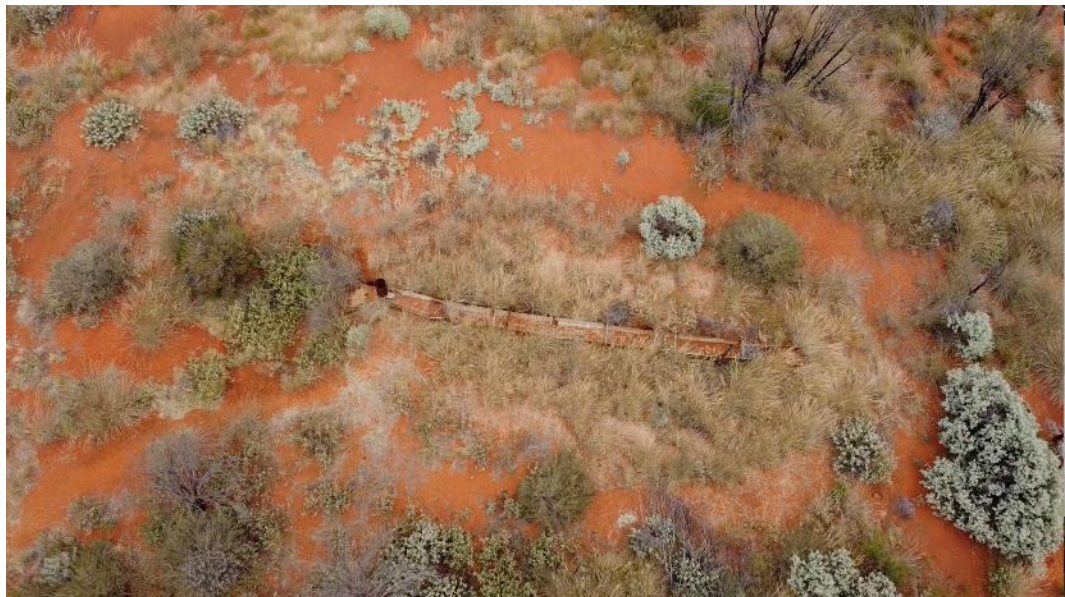
Well 13, Pulpuruma

Unmaintained. Large camp area, lots of Spinifex. Poor signage.

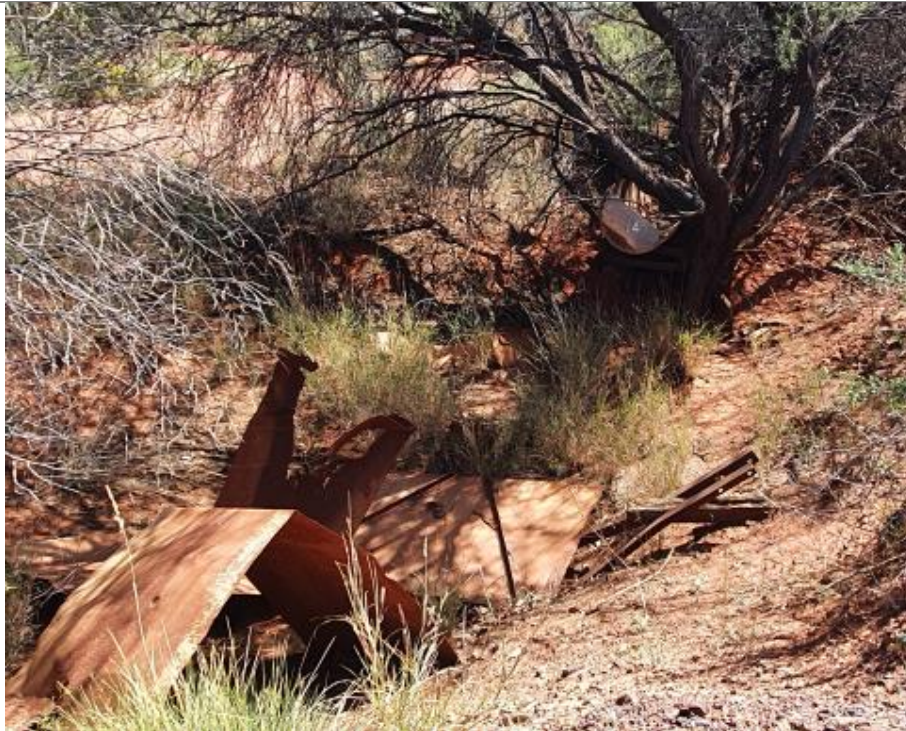
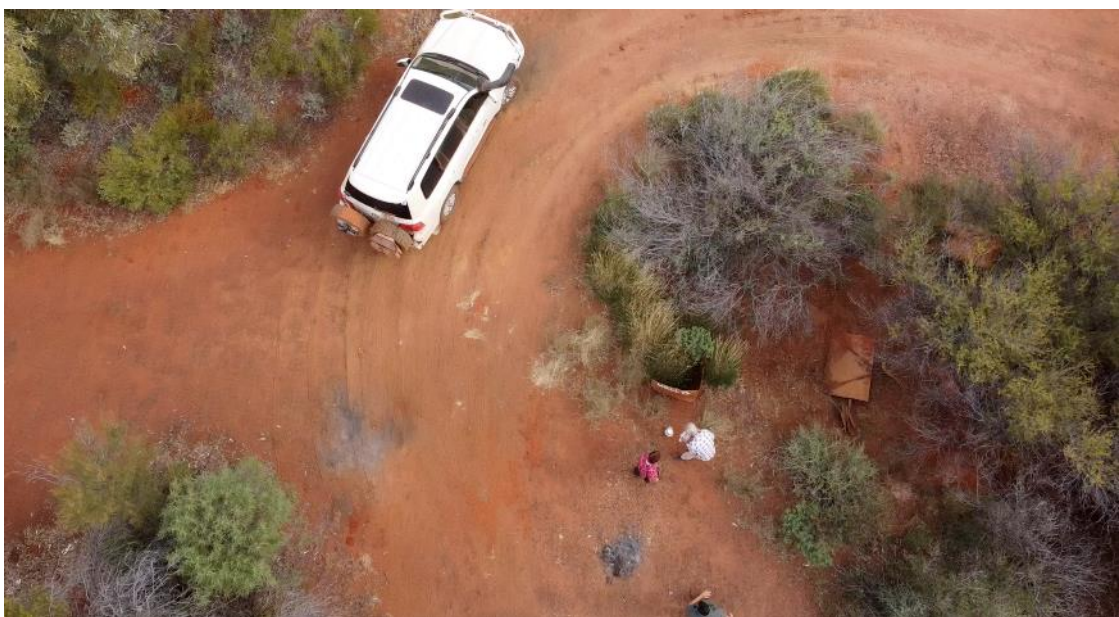
Well 14, Jintjimal

Unmaintained. Poor signage. Memorial to Kevin Albert Weckert & book, med size area to camp, ground sand based and lots of Spinifex.

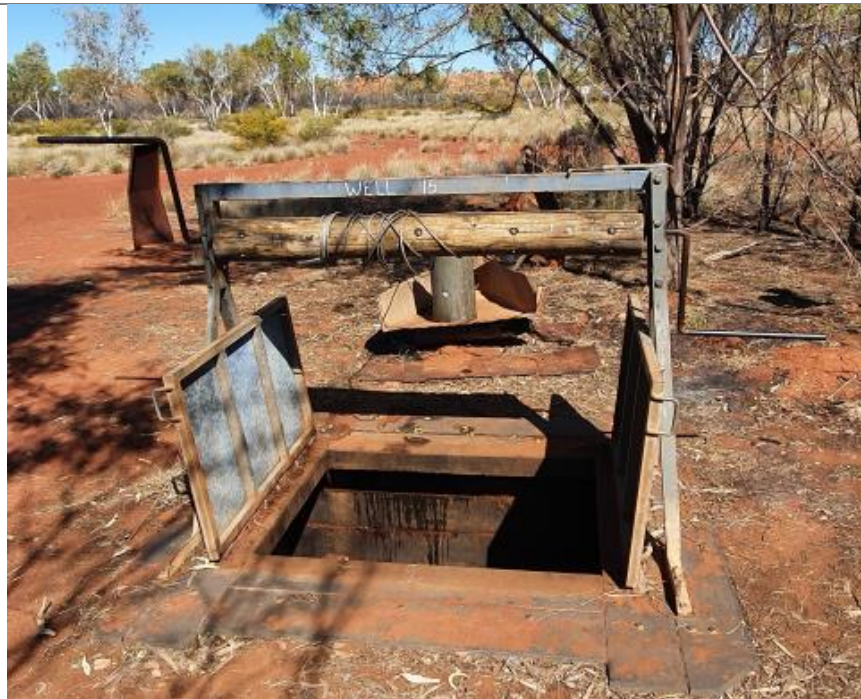
Well 15, Manjanka

Restored. In good repair, plenty of water, toilet in good repair, toilet signs in good condition, unknown working condition of solar light, good camp area.

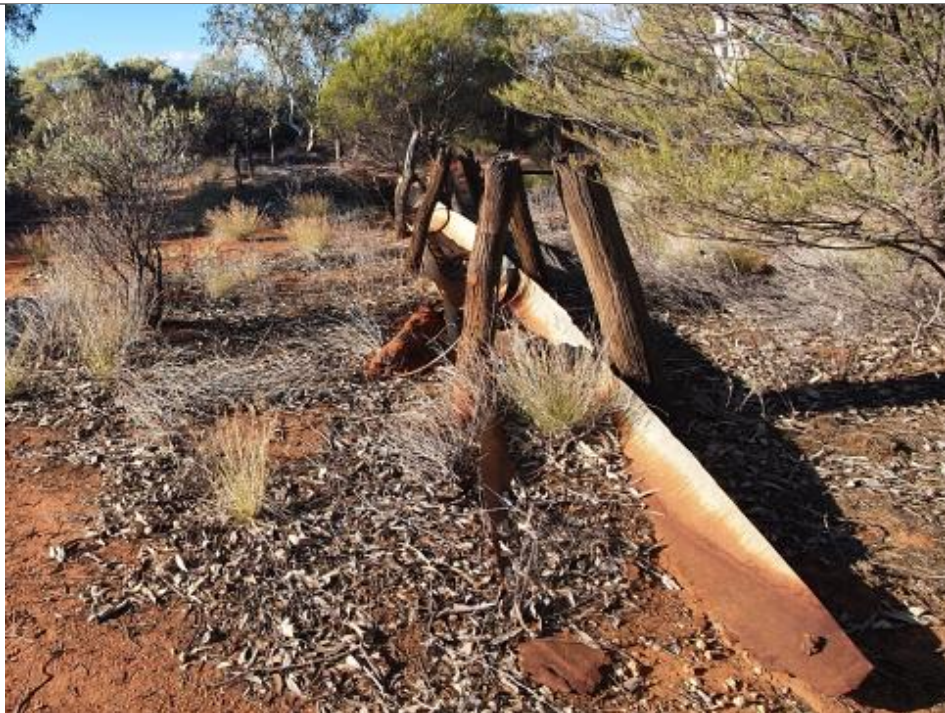
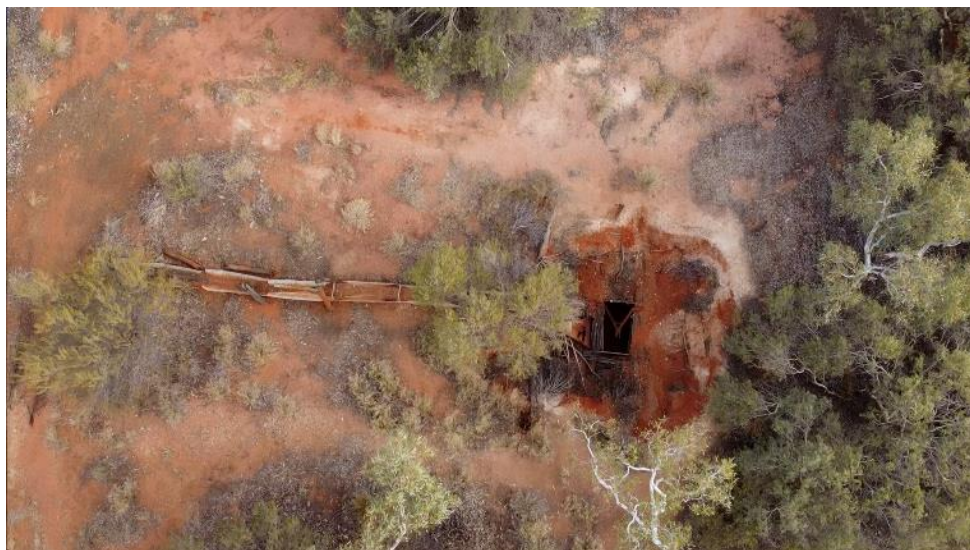
Well 16 Lawulawa

Unmaintained, no water. Good camp area nearby and East of well, small quantity of shaded campsites, scenic, fair amount of spinifex.

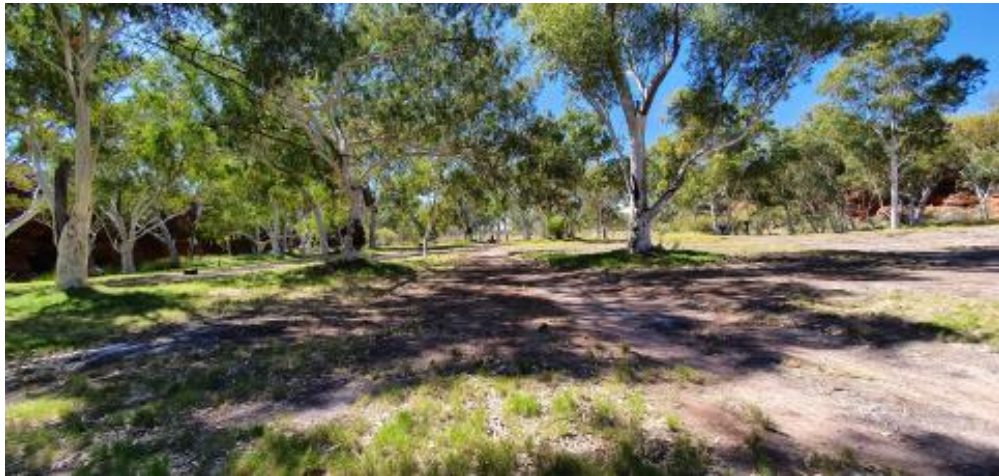
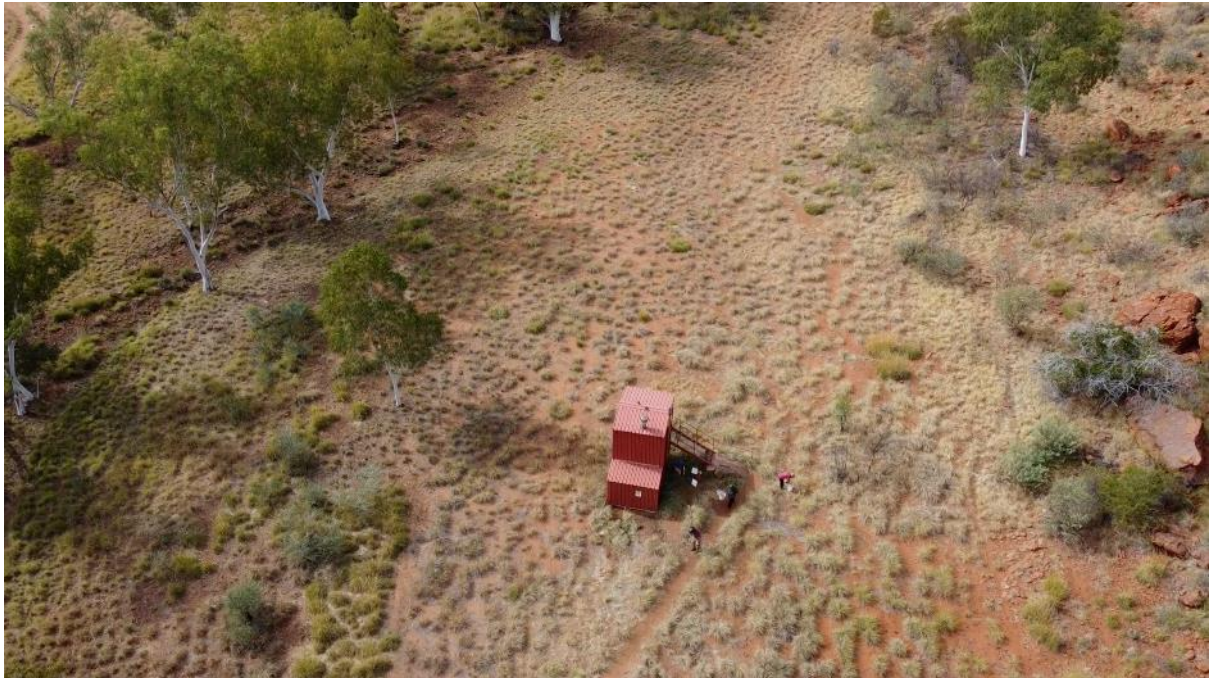
Durba Springs

Cleared grassed camping area with BBQ rings, toilet, donation box, sign shelter and lots of white gums for shade. Very popular spot.

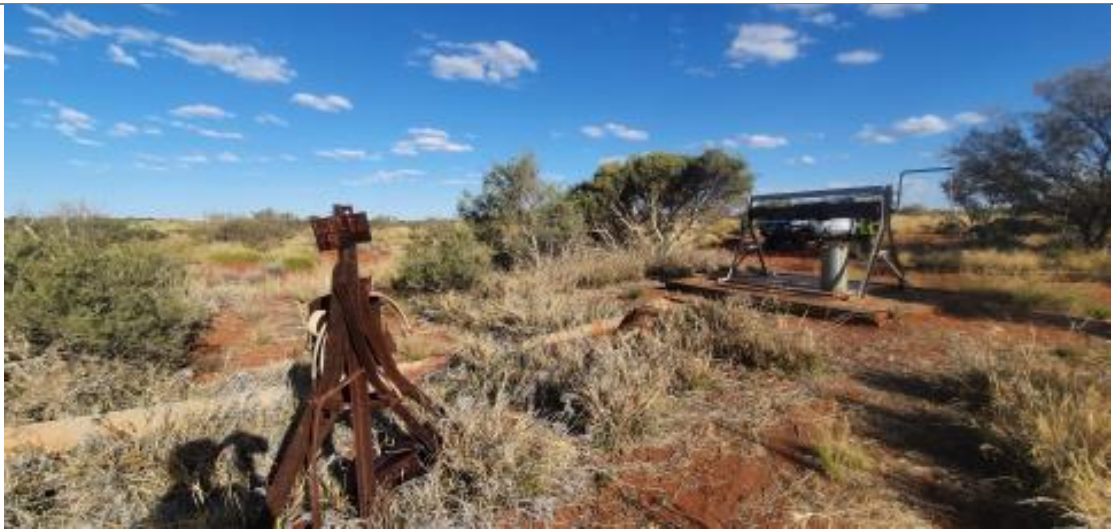
Well 18, Wanykuju

Restored, in good repair, top well boards badly damaged from termites, scrub, little shade, only small area to camp. Water slightly salty.

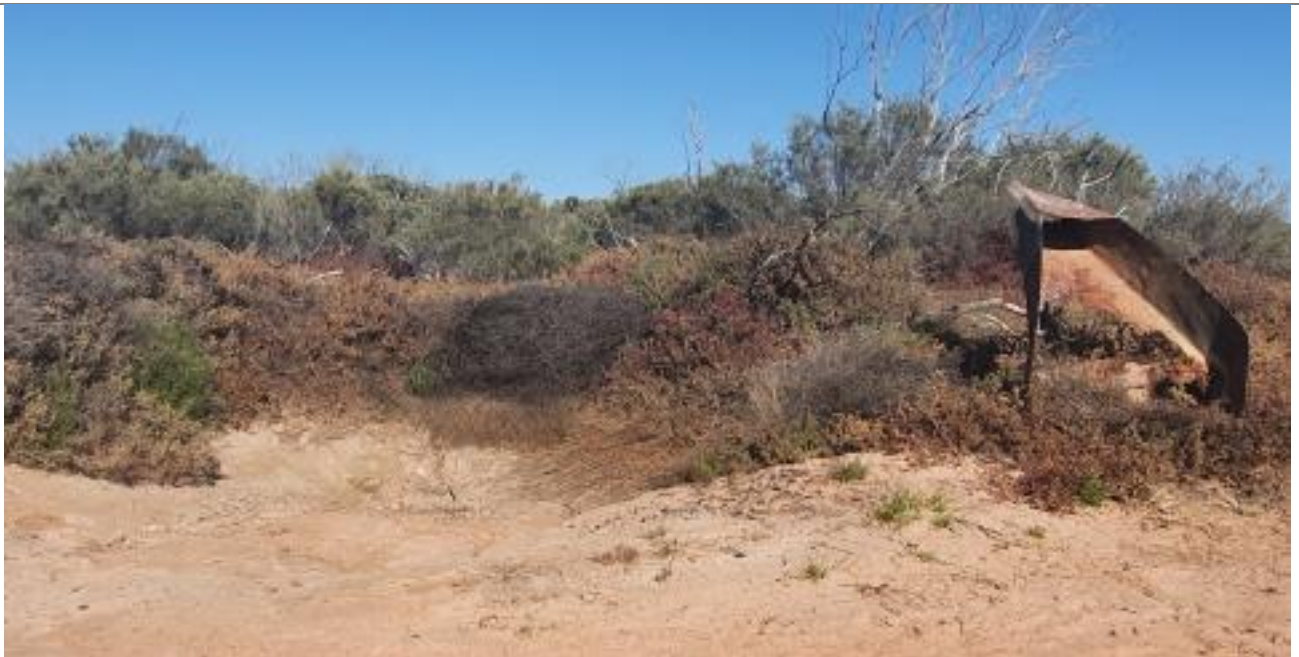
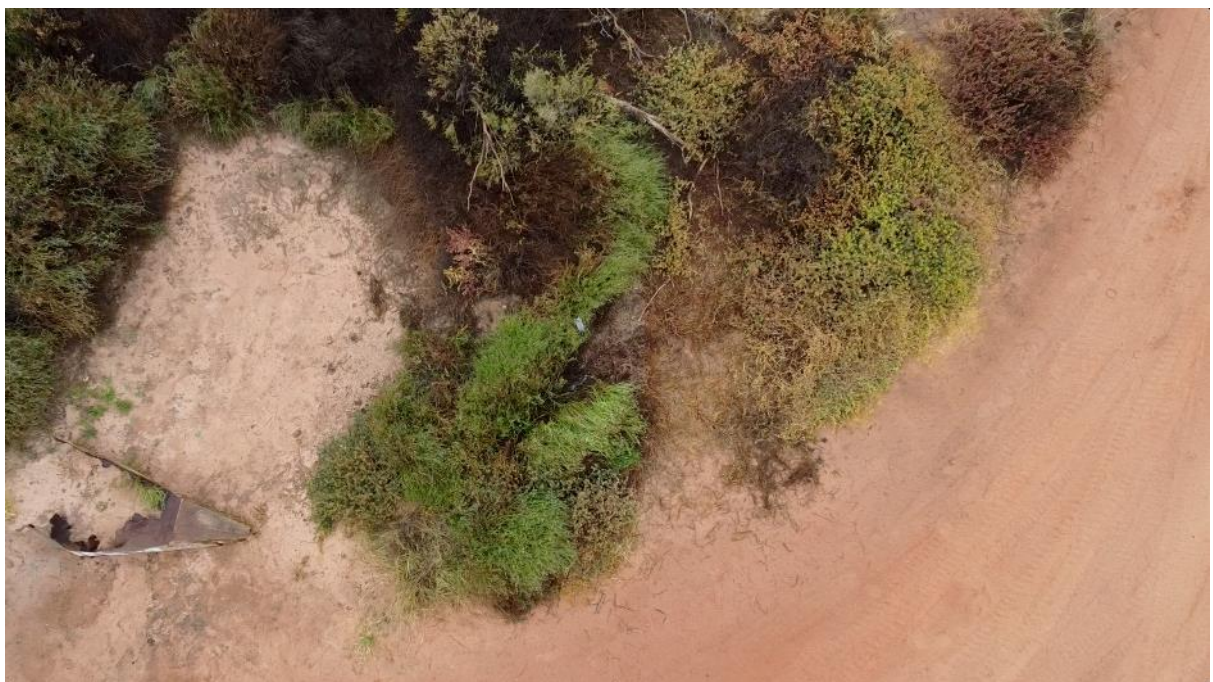
Well 19, Kunangurtiti

Unmaintained, dry small clean area to camp, clay ground base, medium vegetation on boundary of well area

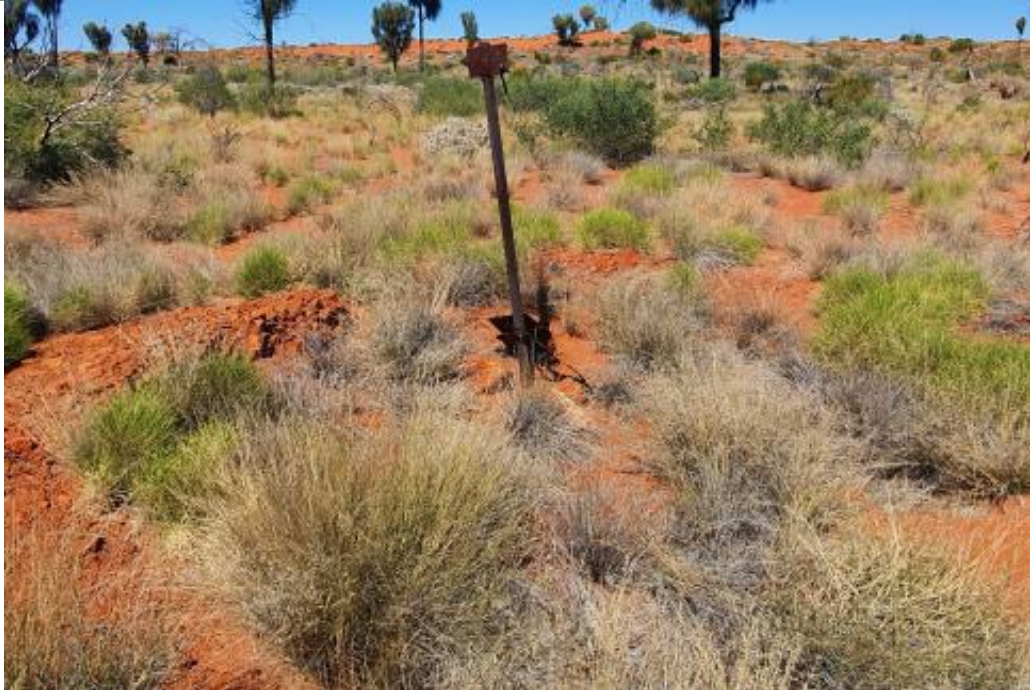
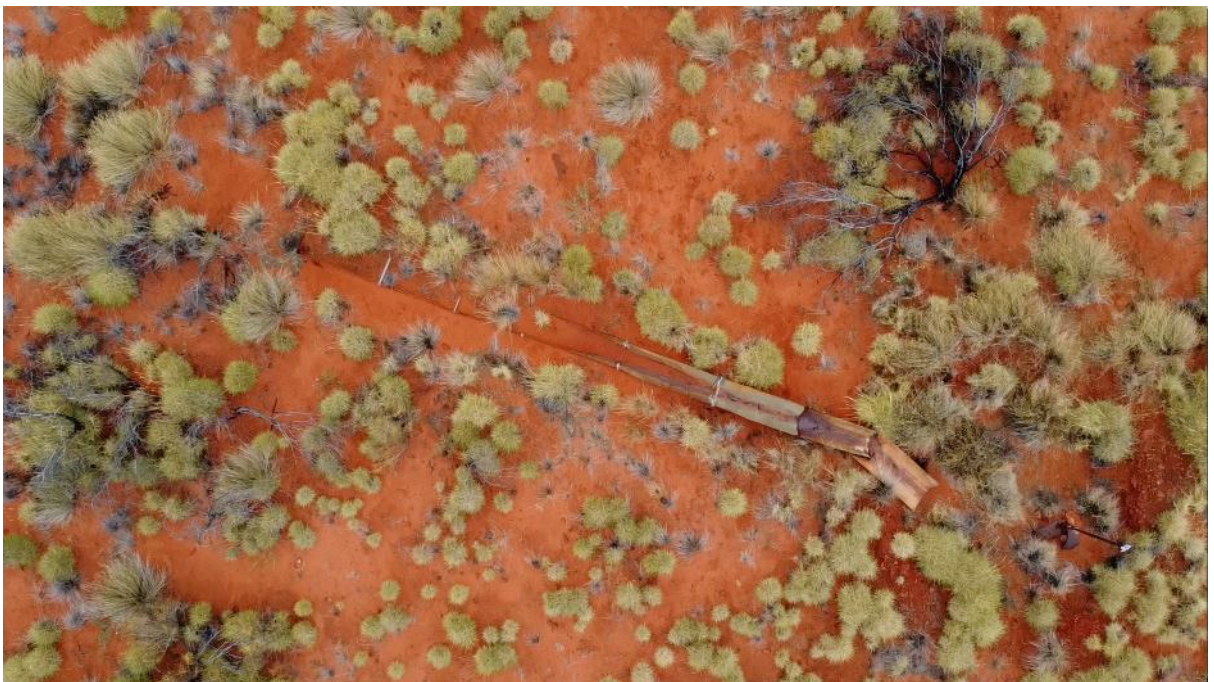
Well 20, Karanyal

Unmaintained, dry, few camp spots, some shade from Desert Oaks, sandy base.

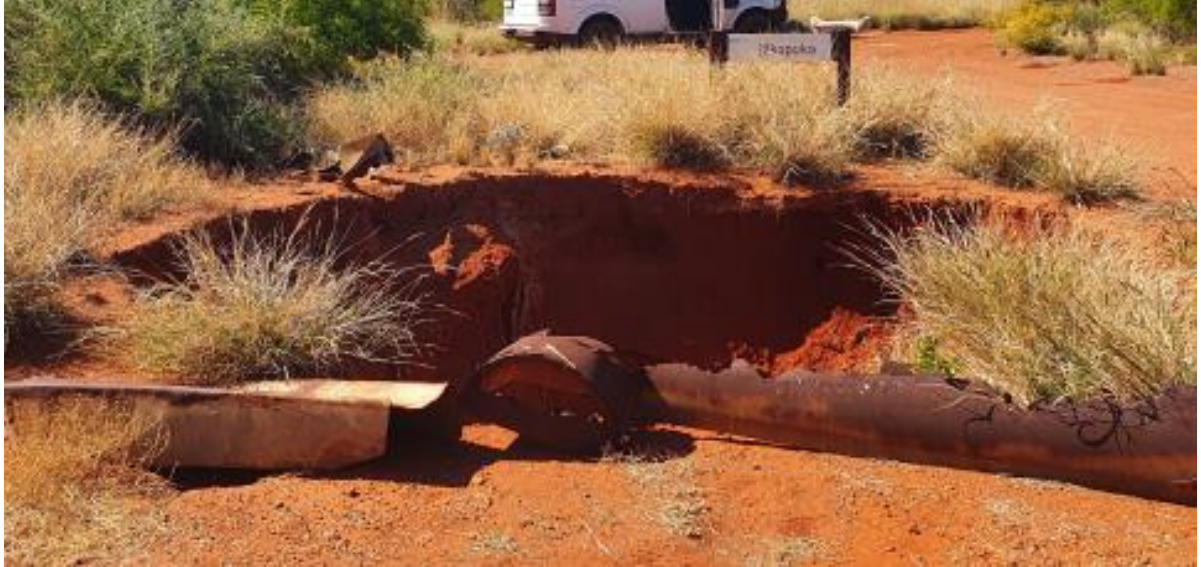
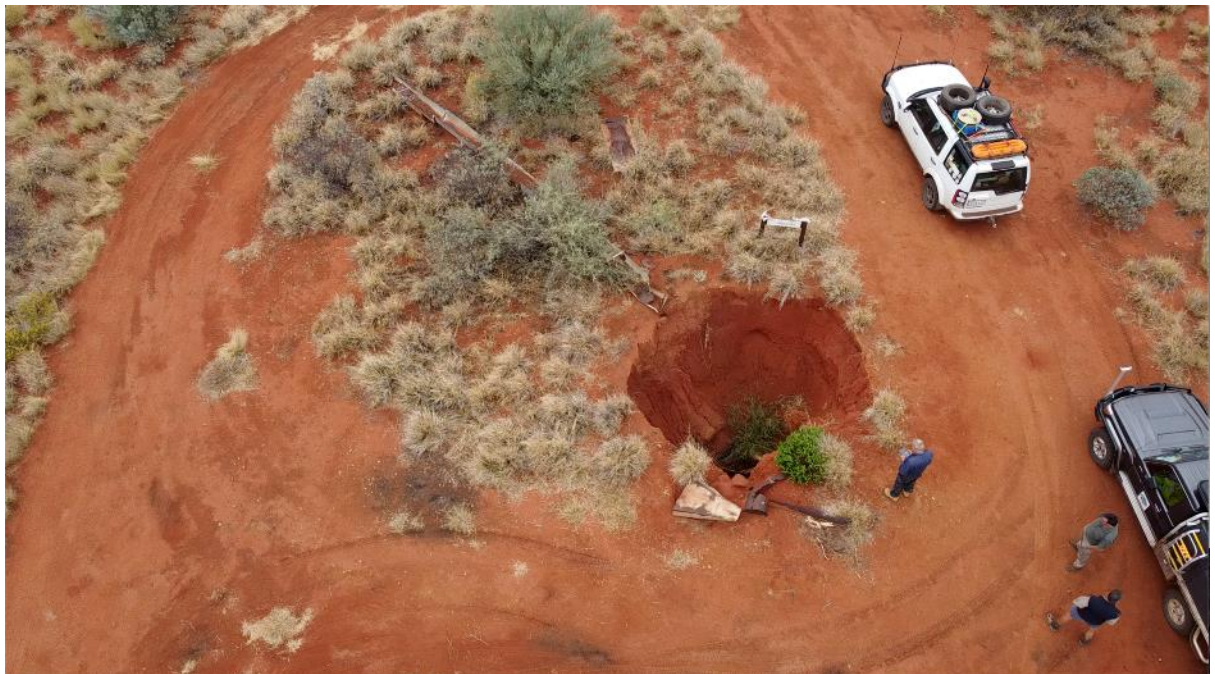
Well 21, Jilkupuka

DescriptionUnmaintained, dry, no facilities, very small area

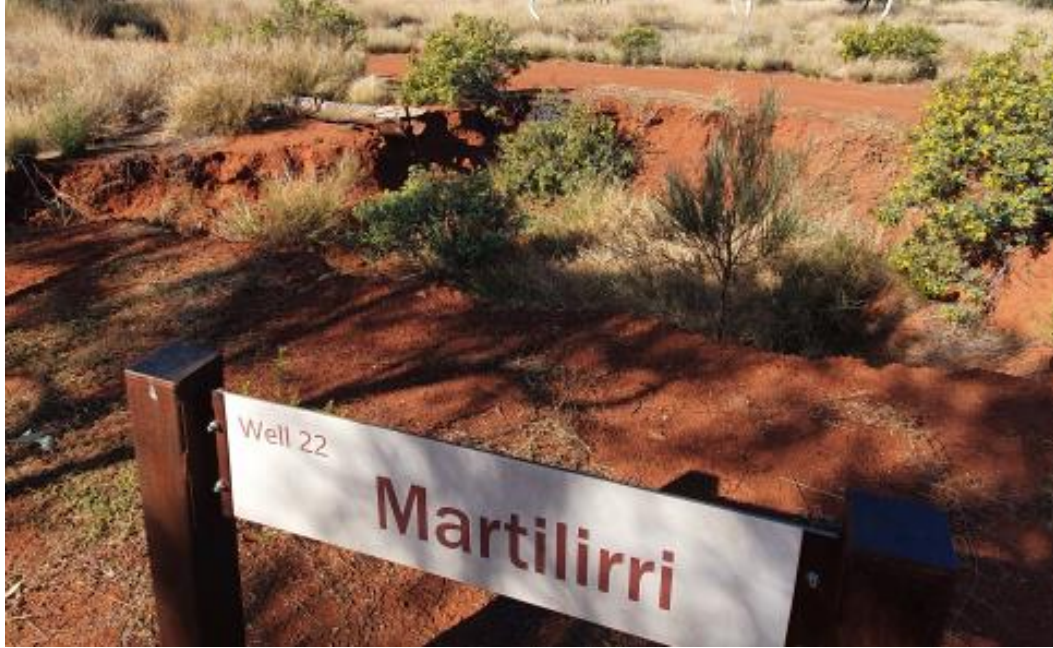
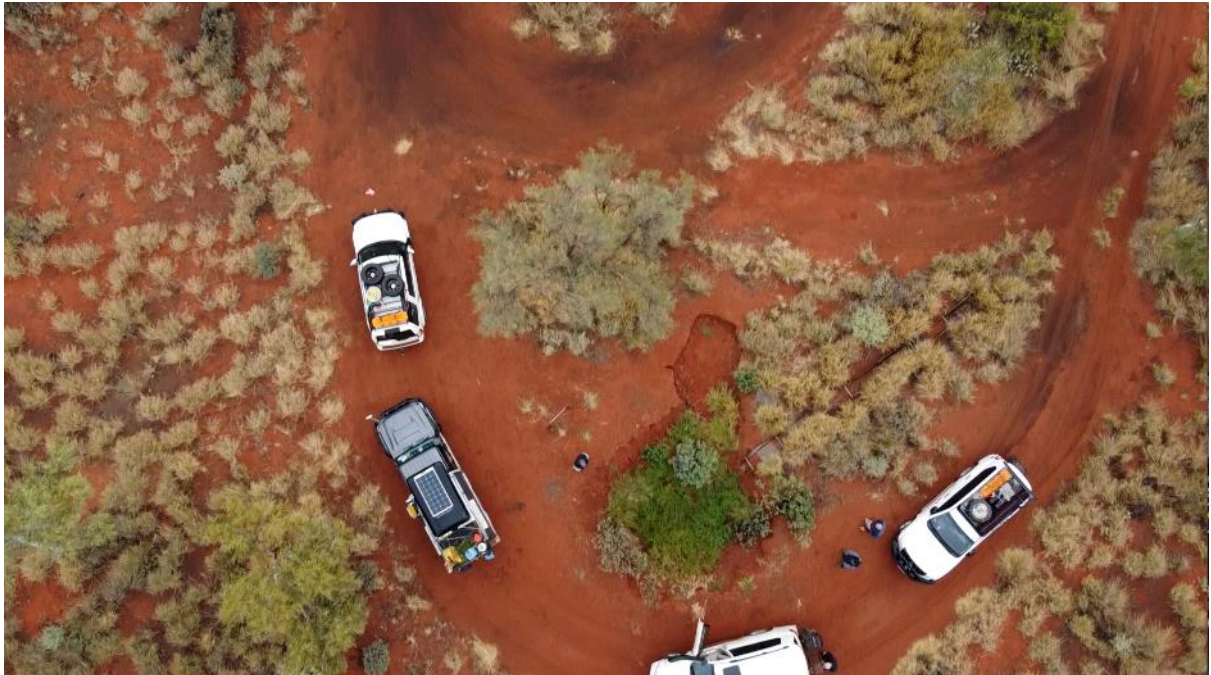
Well 22, Martilirri

Unmaintained, dry, very small area to camp

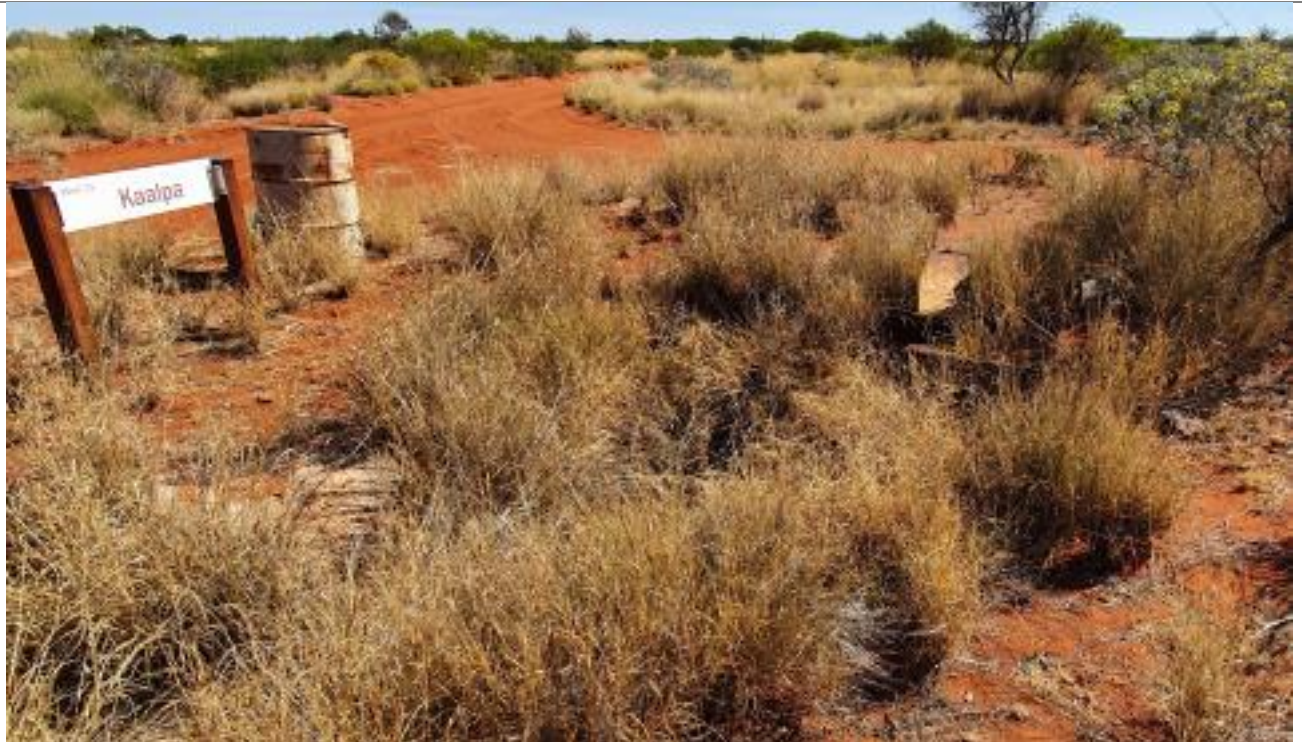
Unmaintained, dry, medium size camp area, sand base.
