Canning Stock Route Audit Report

Prepared for Track Care WA
Author: Rod Durston
August 2022
Revised June 2023

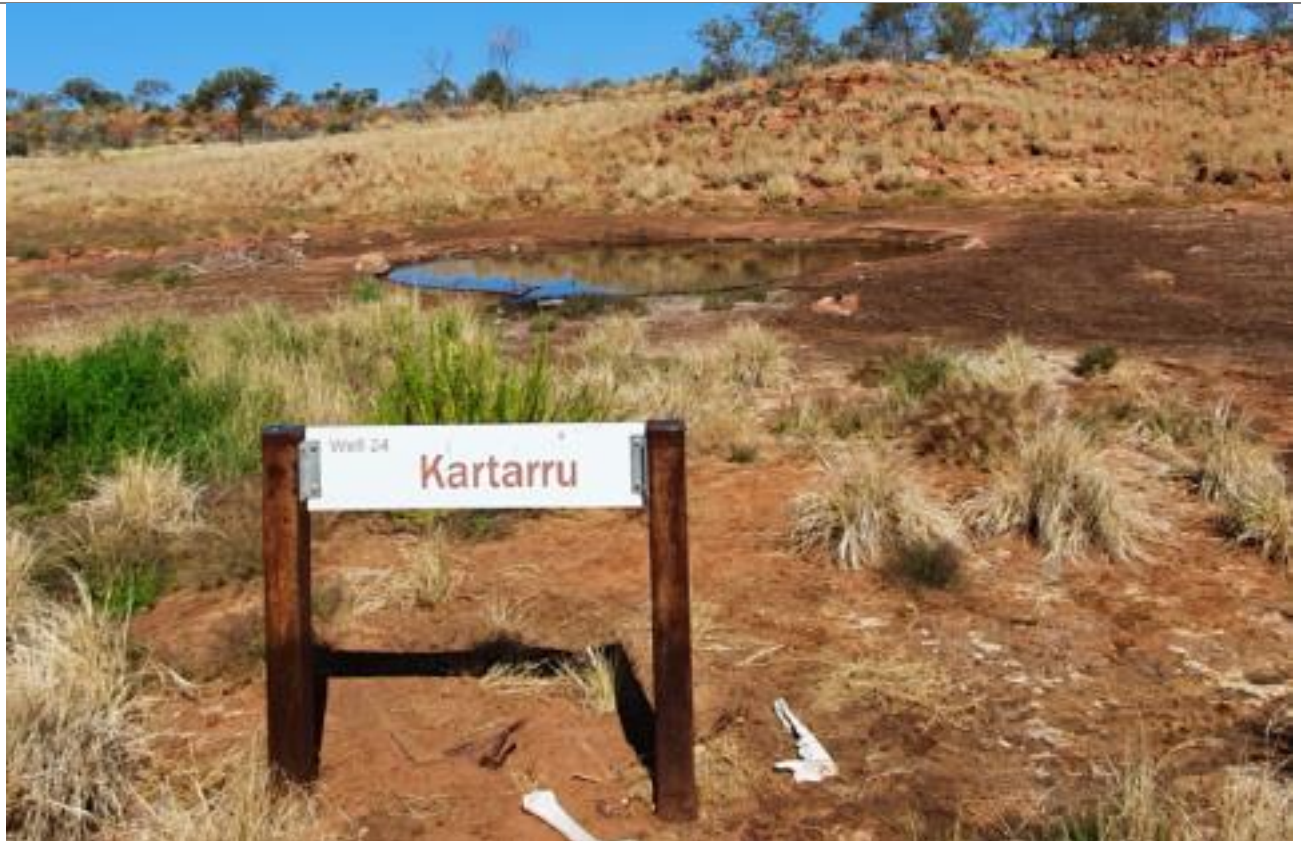
Well 24, Kartarru,

Unmaintained, filled in, small pool, no sign at track entrance, large open area to camp, no shade, low trees & scrub.

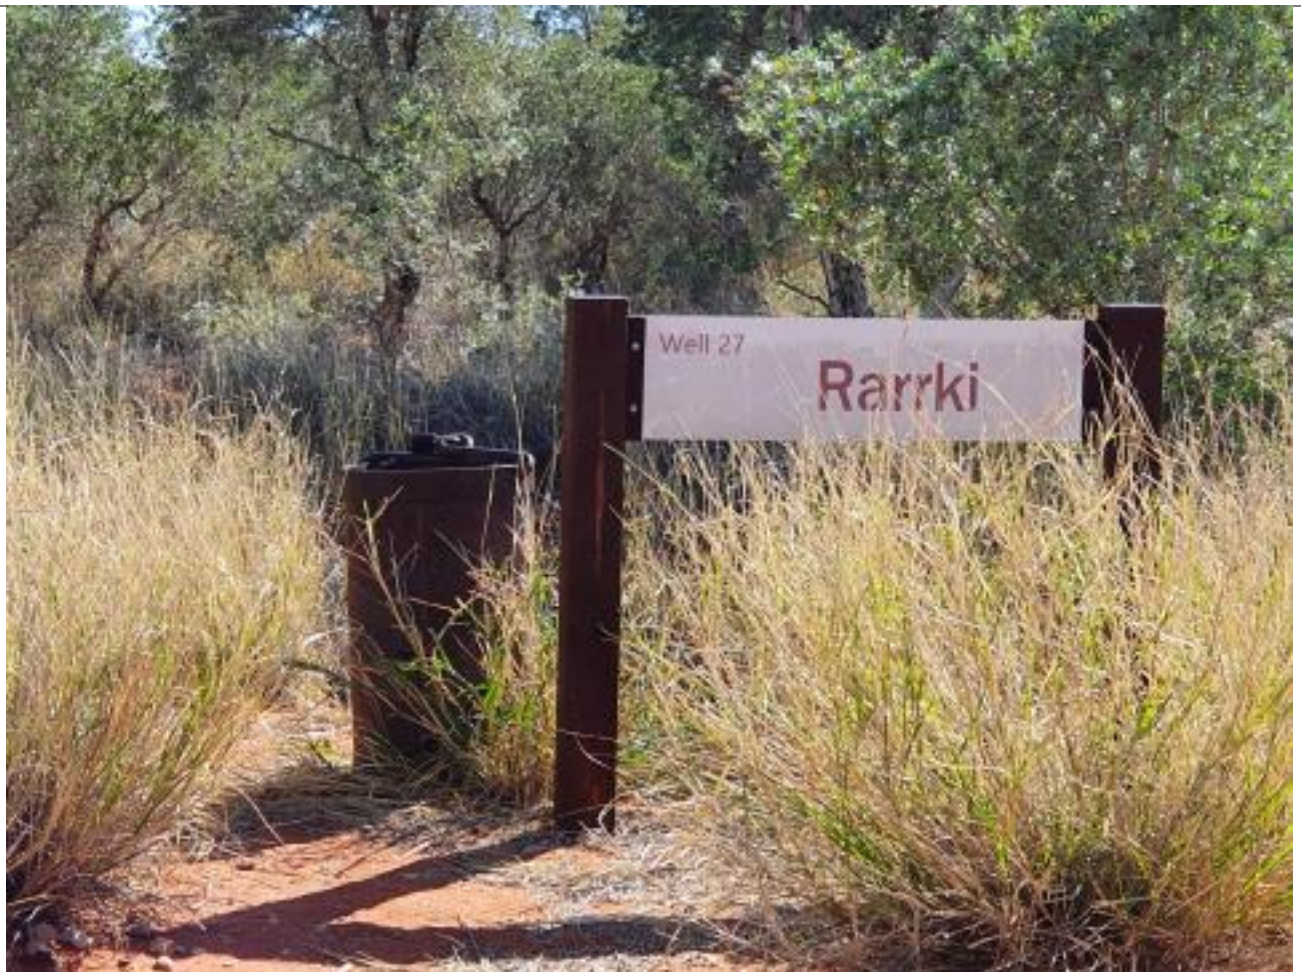
Unmaintained, dry, Desert heath, Paperbark overstory, Buffel grass, small area to camp, sand base, little shade.

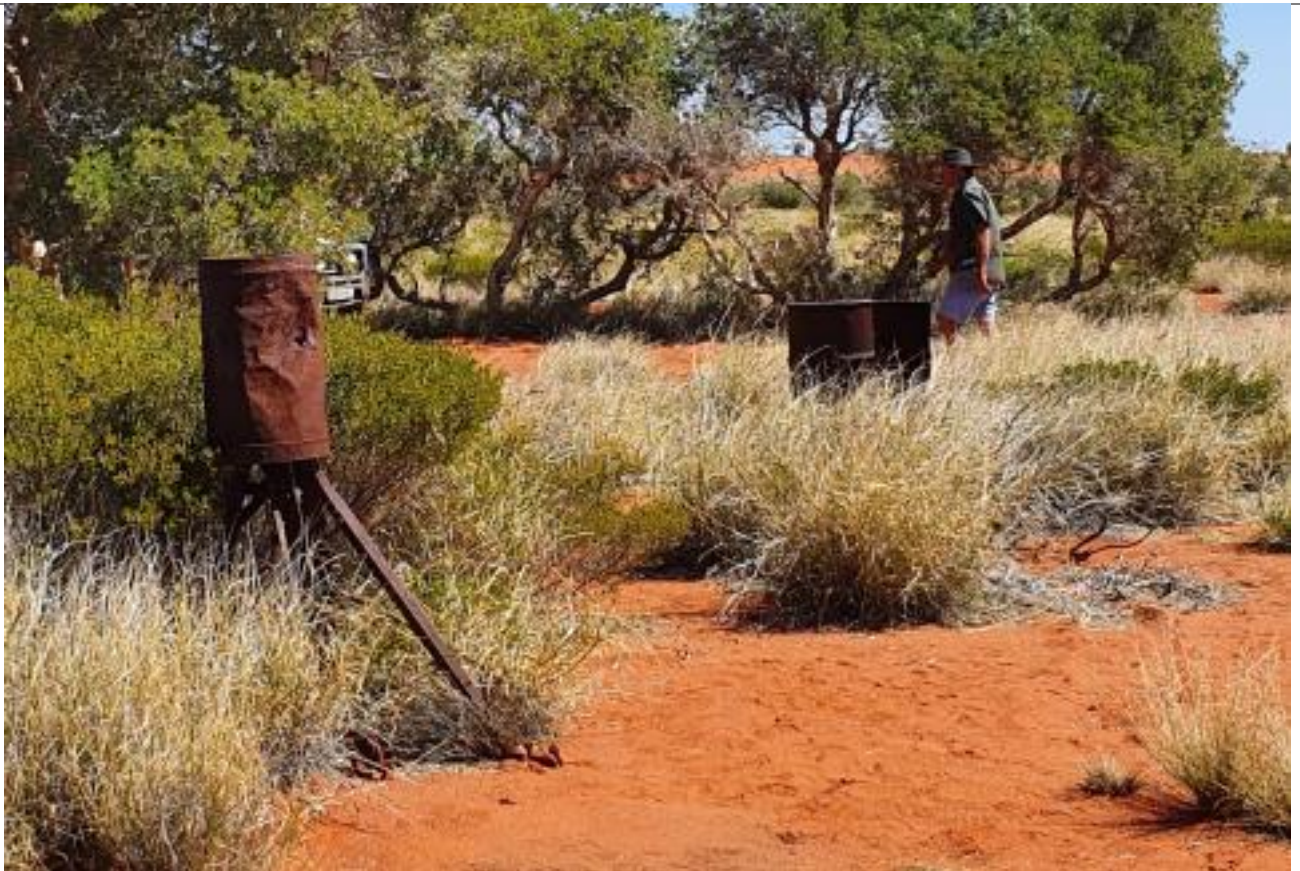
Unmaintained, filled in. Signage poor, No28 scratched on side of well bucket. No CSR sign, medium size area to camp, small shade from 3-4 med size trees, low veg around perimeter, sand base.

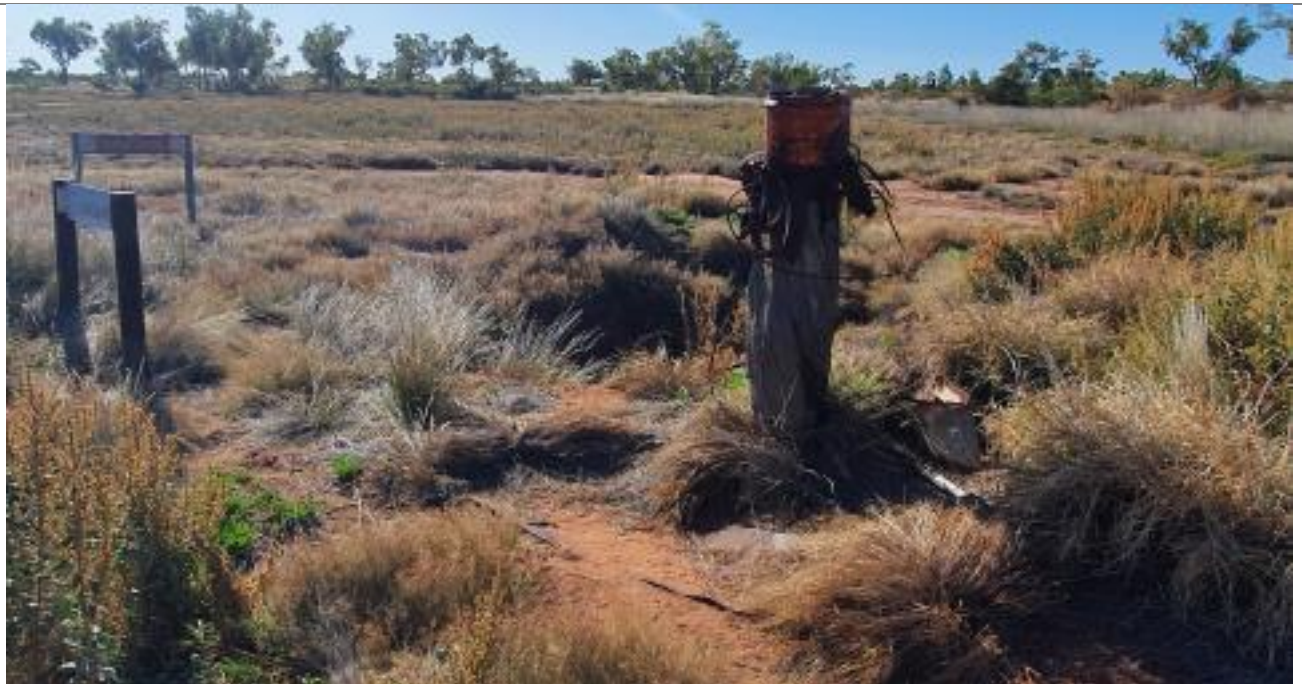
Unmaintained, dry. Remains of blazed tree, no visible CSR sign, small area, ground sand base, Spinifex & Buffel grass. Mujingerra cave nearby with dead camel in it.

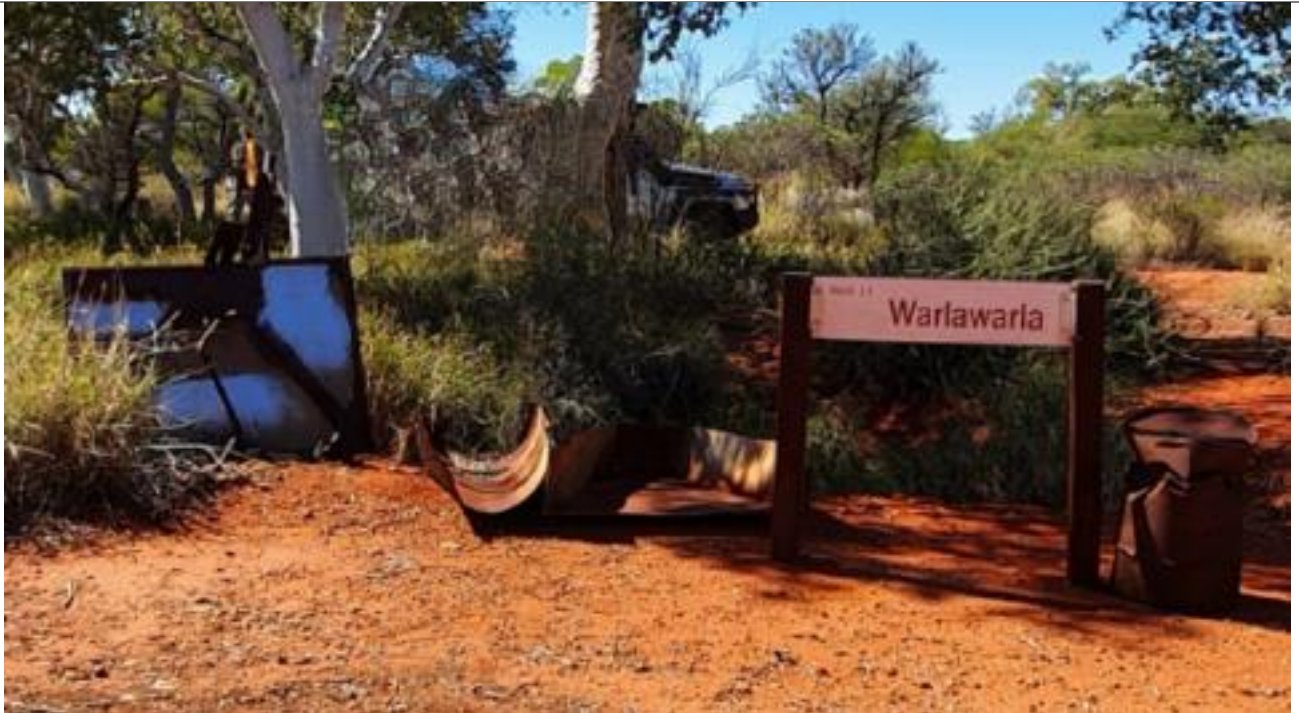
Well 31, Warlawarla**Lat. -22.525471****Long. 124.407188**

Unmaintained, filled in. Shade at well area, small camp area nearby, good camp site, Buffel grass.

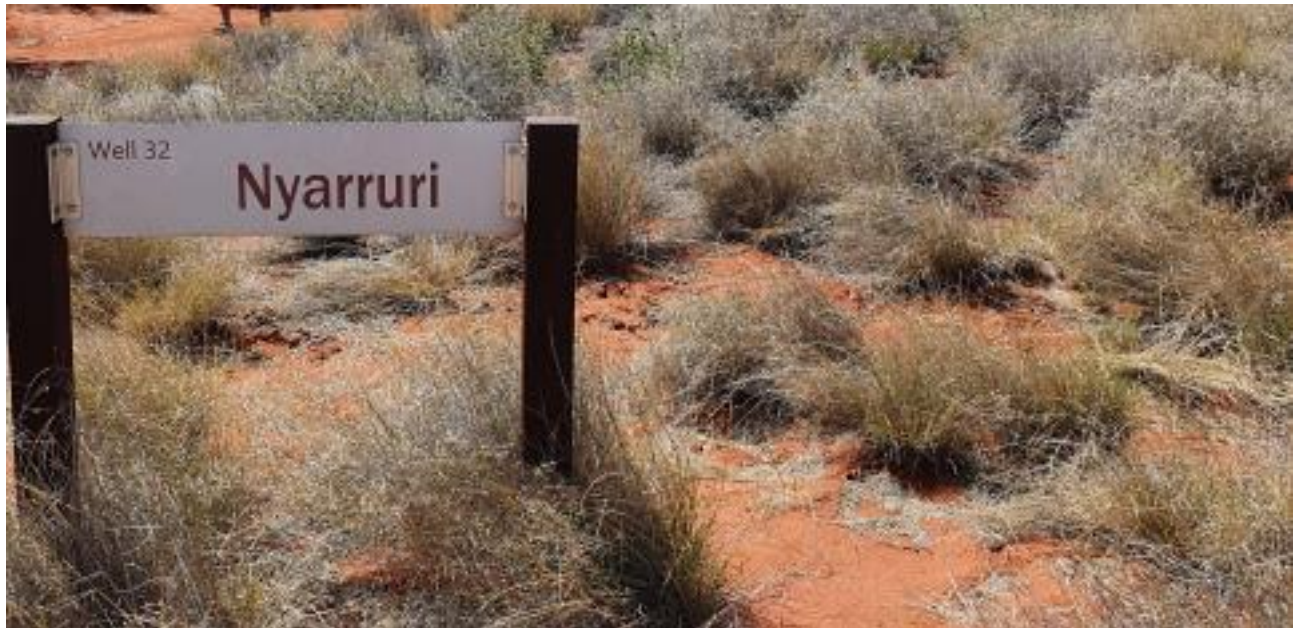
Unmaintained, filled in. Open exposed area, Spinifex & Buffel grass, no camping area,

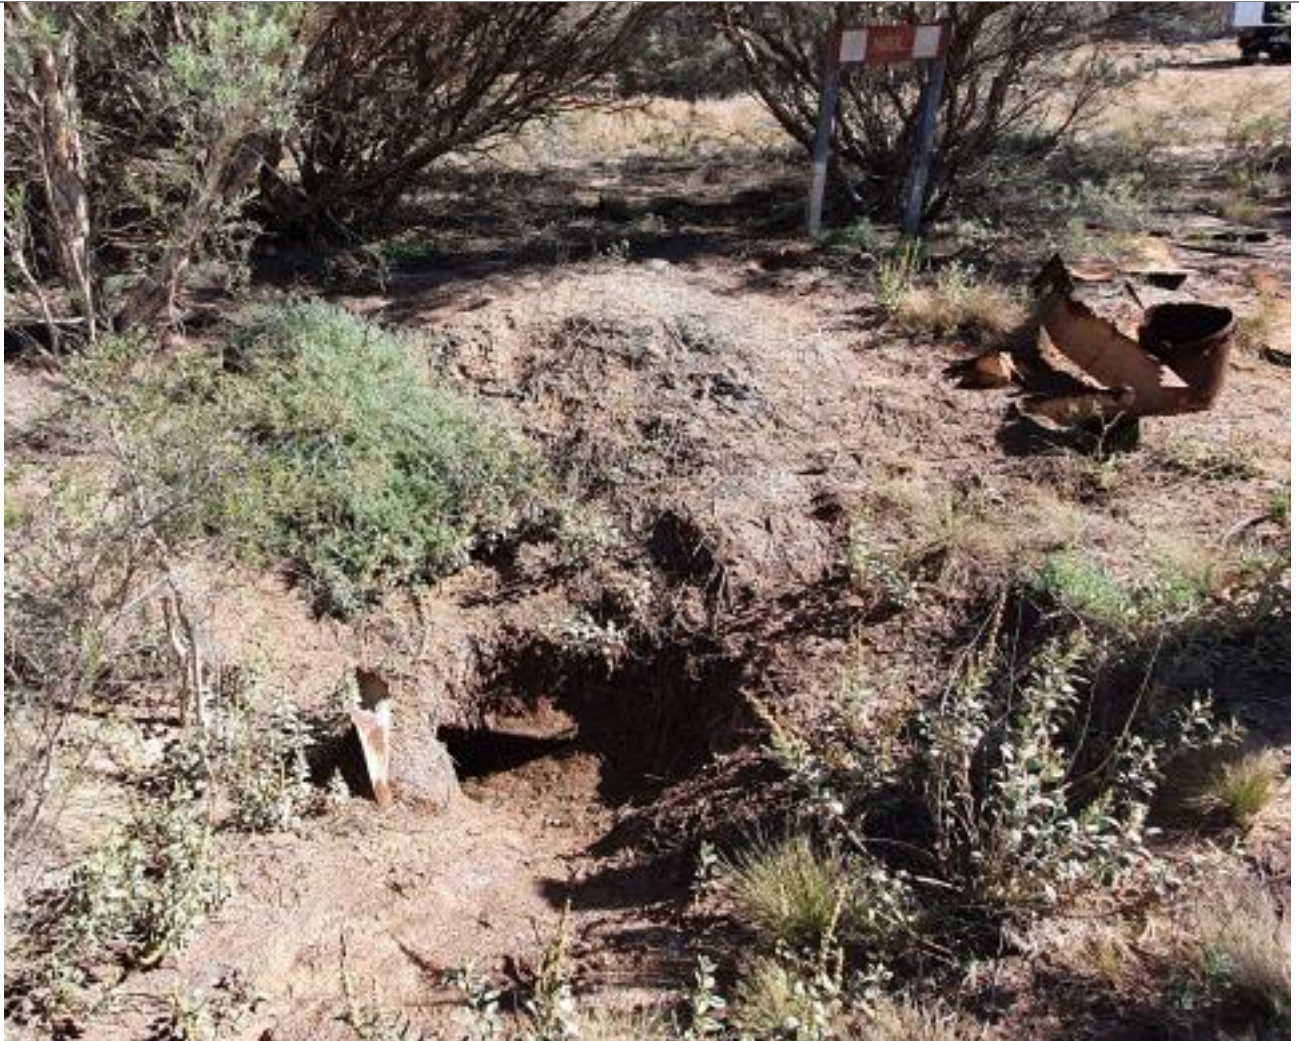
Unmaintained, filled in. Very small area to camp, no shade.

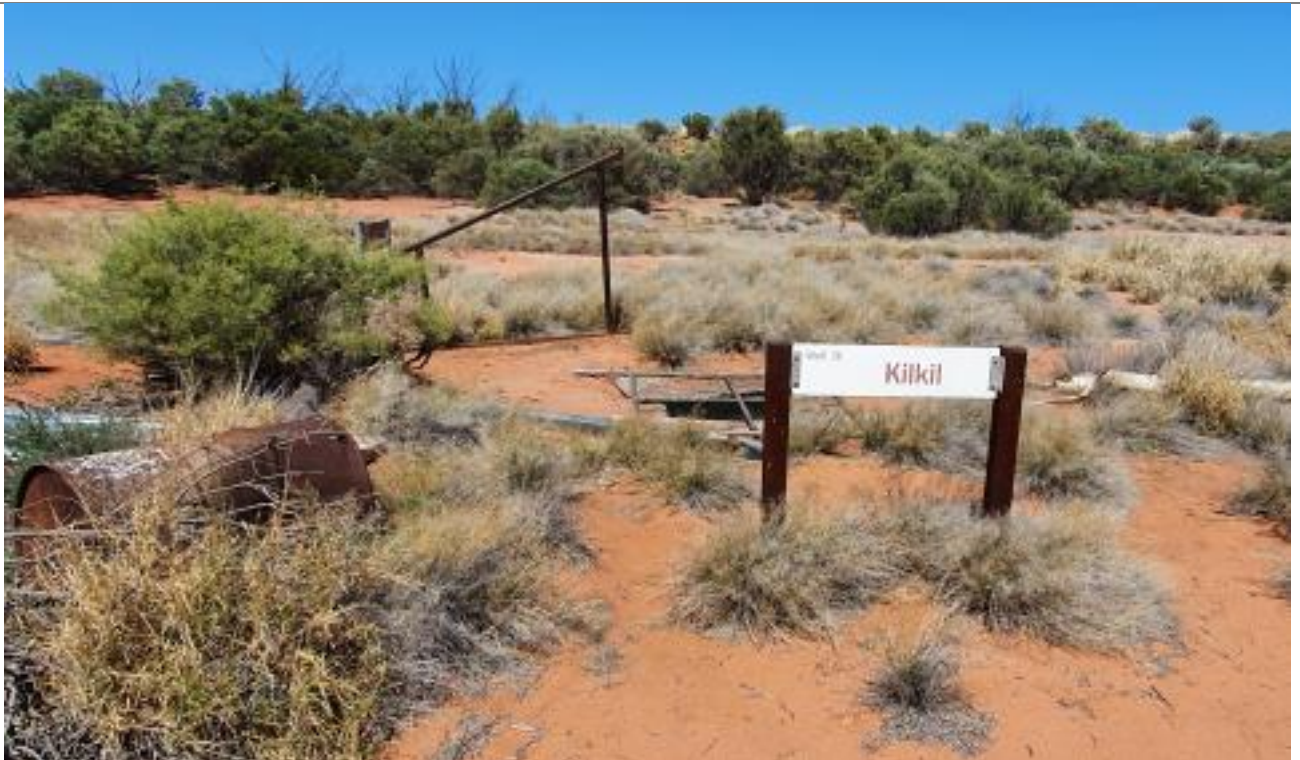
Unmaintained, well covered with wire fence. Good med size camp area, some shade, Buffel grass, sand base.

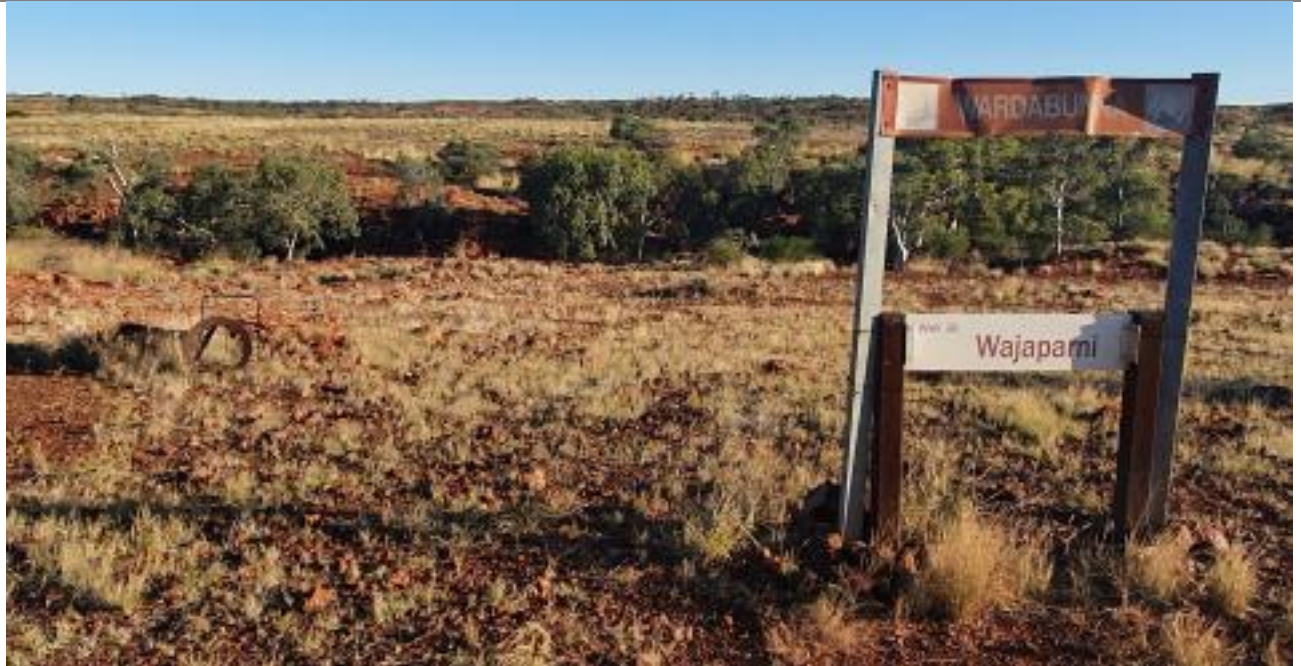
Dry creek, very exposed area, stony base, creek very scenic to explore, camp area to the West nearby.

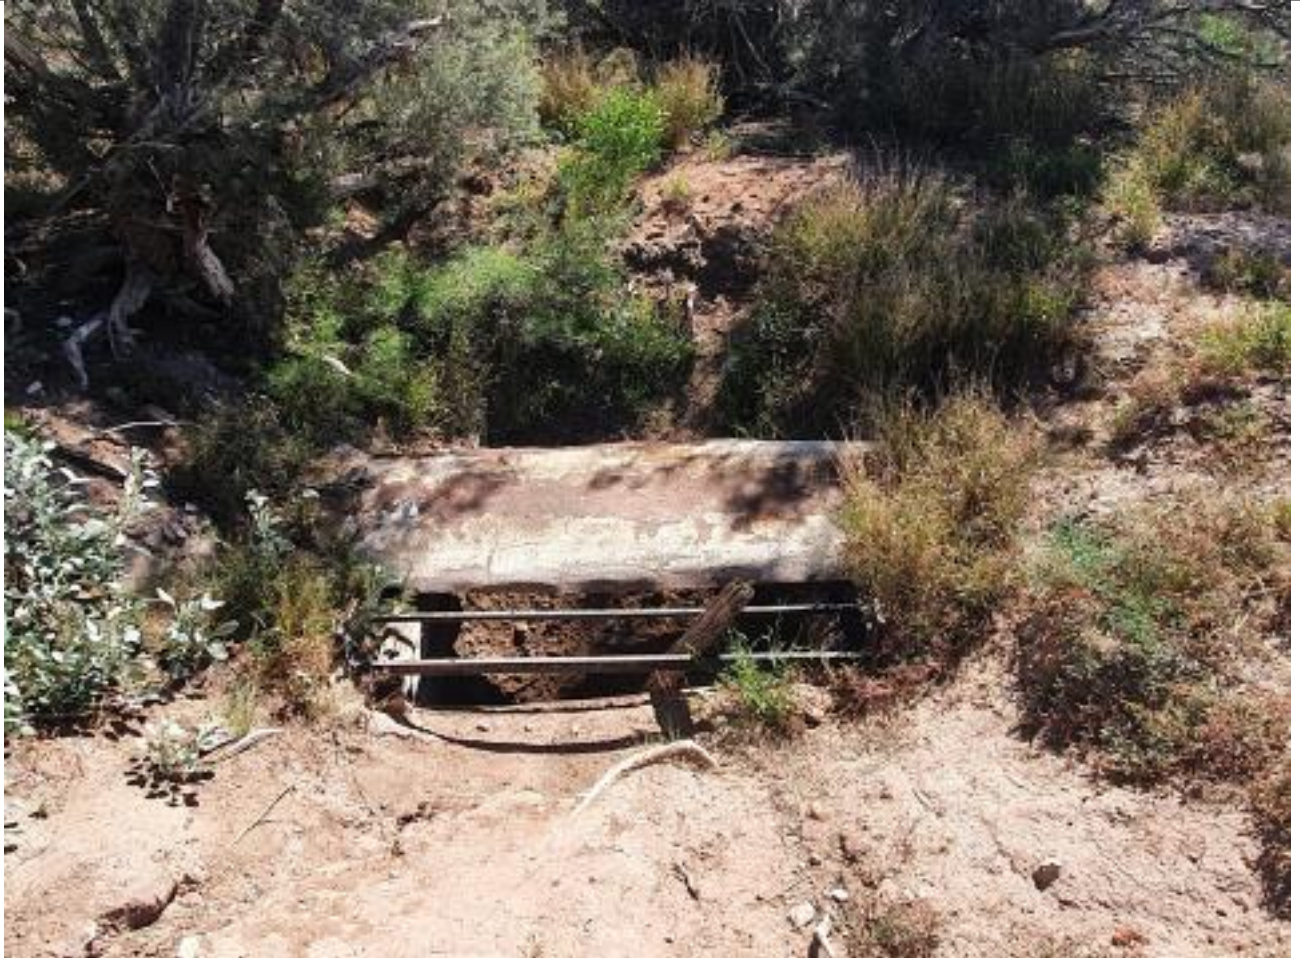
Well 39, Kukapanyu**Lat. -21.766954****Long. 125.651433**

Well partially covered with tin sheet, small amount of water. Exposed & open area, medium vegetation at well site only. Tufted grass/soft spinifex, original whip pole laying nearby.

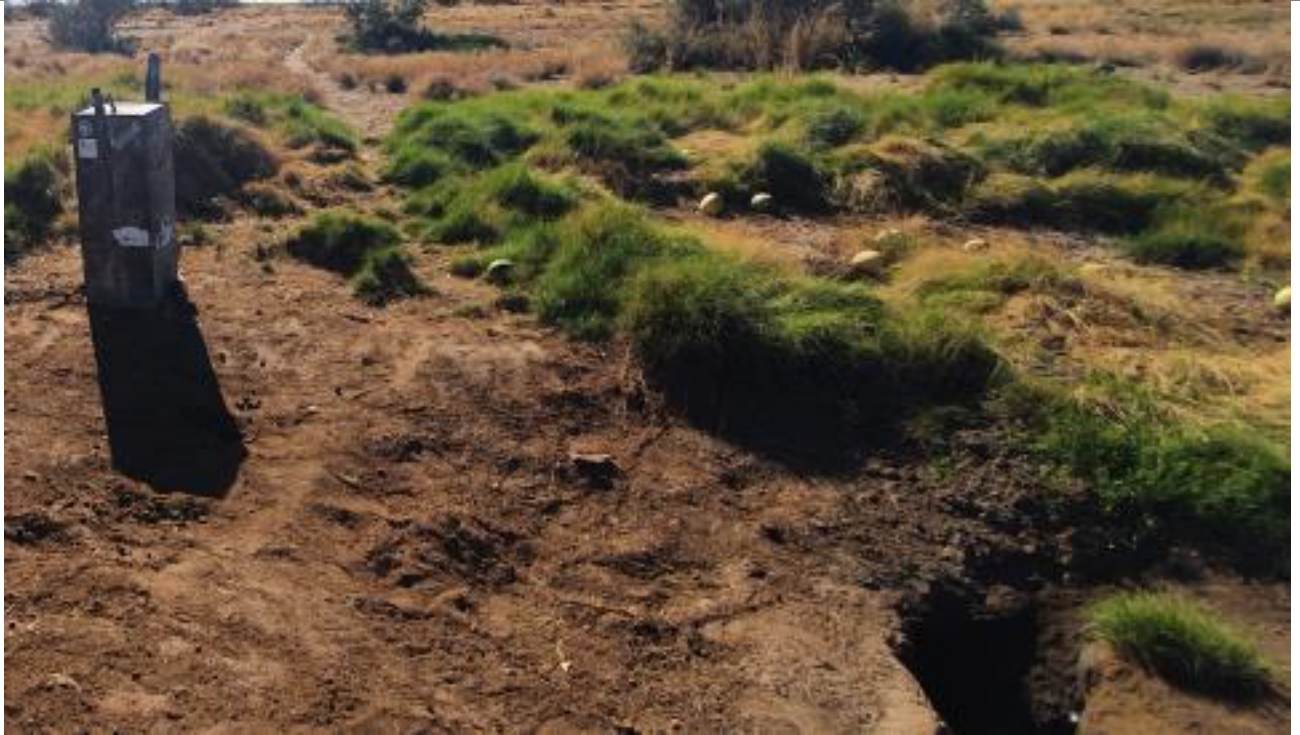
Unmaintained, water available, Signage poor (old tank written on), Very exposed med sized camp area, sand base, Buffel grass, good tasting melons!

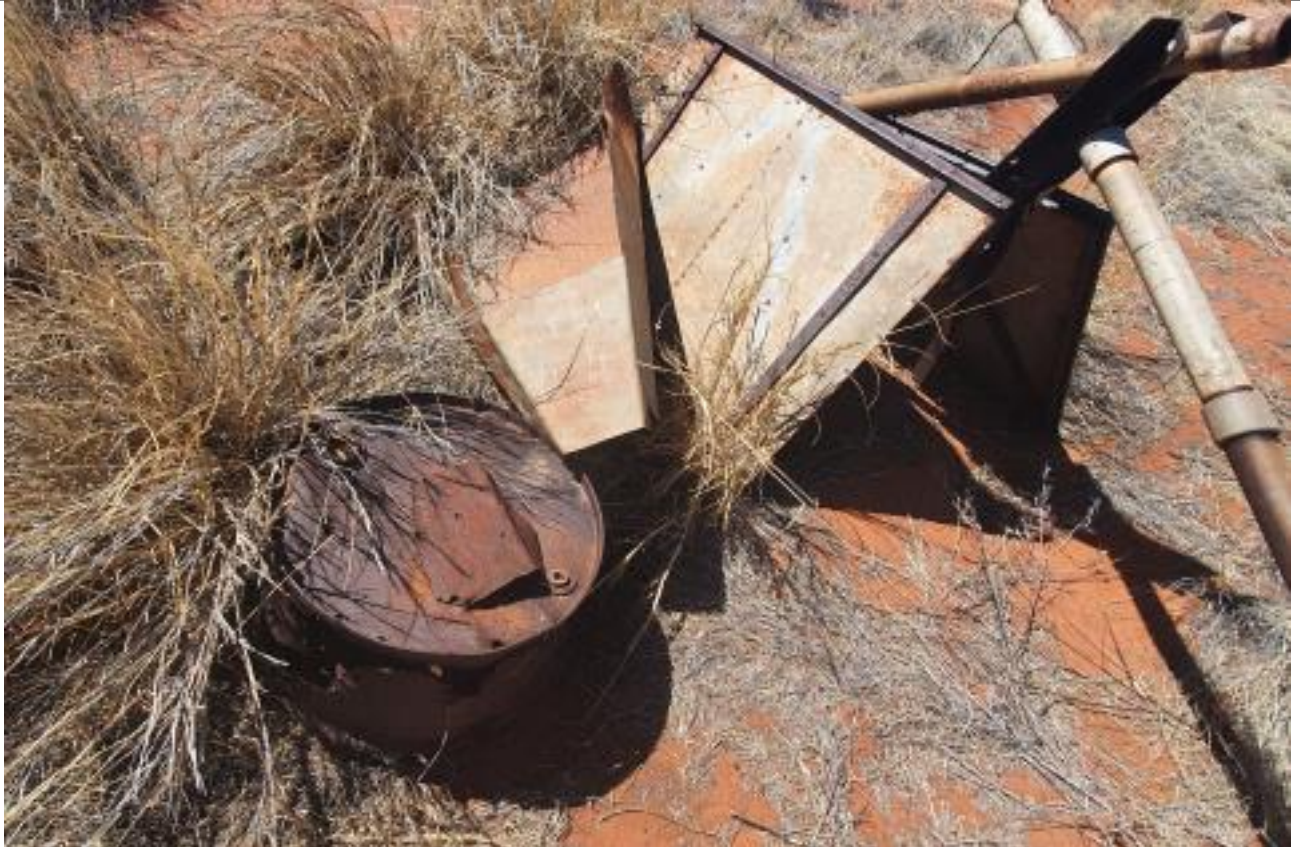
Unmaintained, filled in. Signage very poor (scratched on old trough), Open & exposed area, sand base, Buffel grass.

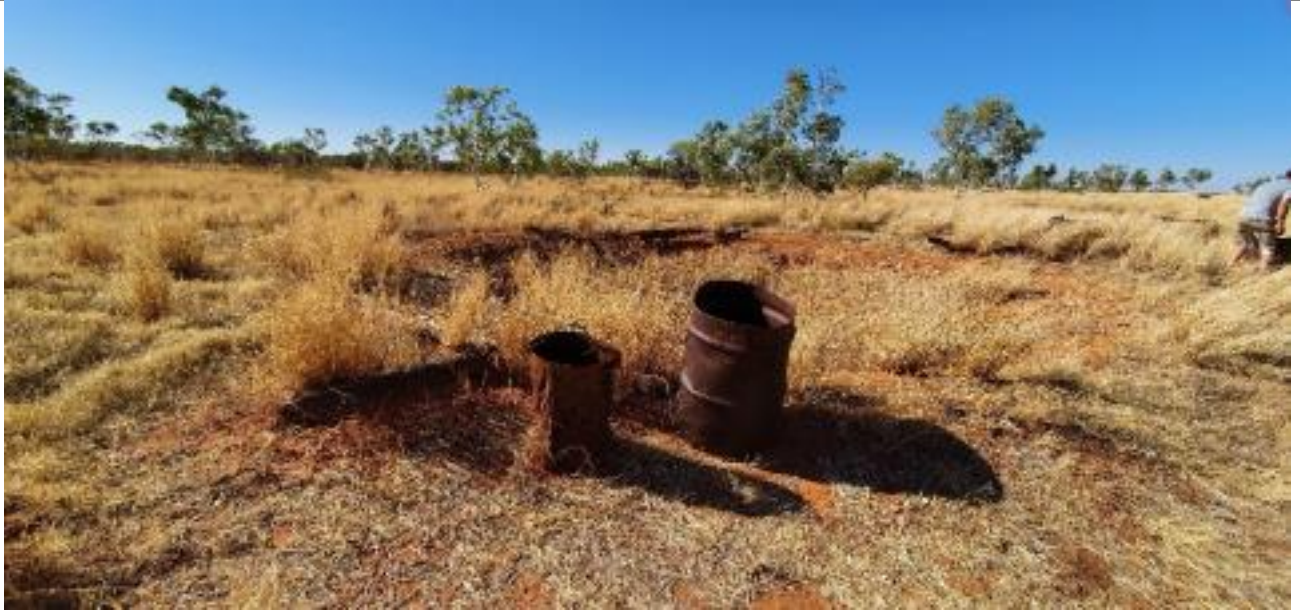
Unmaintained, filled in. Signage poor (faint figures on side of drum). Large flat camp area, open & exposed, sand base, Buffel grass.

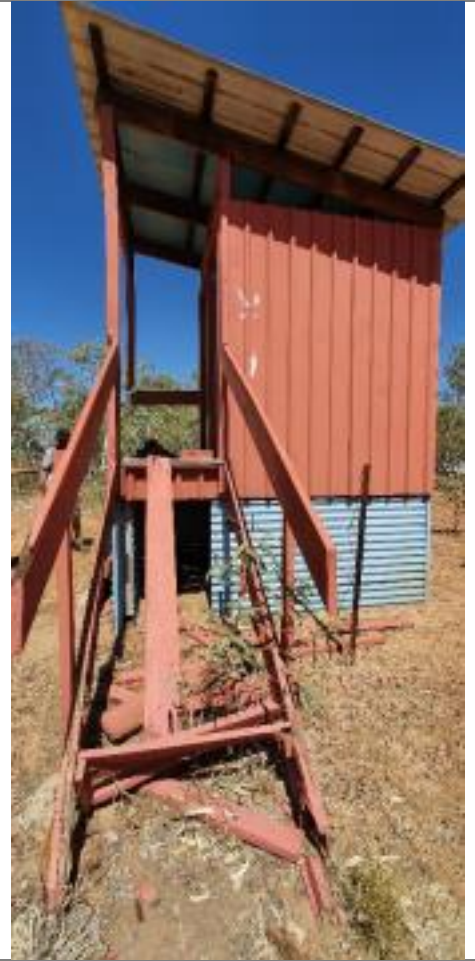
TOILET

Structure has significant termite damage and is in a dangerous condition. Composting bin and pedestals seem to be ok. Solar system present but unknown use or condition.

Some of the toilet trailer tyres at Derba Springs and Well 49 needs replacing and the toilet at Lake Stretch is in a dangerous state due to termite damage. At the time of writing it's unknown who

constructed this toilet and therefore who should repair it. It will be a major project to complete as it requires a complete rebuild. Apart from some minor repairs undertaken, in general the toilets are in good condition there does not seem a need for extra toilets along the CSR.
